<u>TS No.</u>	<u>Symptom</u>	<u>Possible Cause</u>	<u>Remedy or Reference</u>	<u>Replacement Part</u>
1	Cooling water does not flow to diffusion pump.	a. Water pressure too low b. Cooling water lines for diffusion pump clogged.	a. Increase flow rate b. Unclog or replace water lines	
2	Instrument is not energized by depressing POWER switch.	a. Loss of power to instrument b. Fuse F1 blown c. Relay Y4 inoperative	a. Check circuit breaker for line supplying power to instrument. b. Replace F1 c. Replace Y4	F1 (15A) Y4 (MY4)
3	Rotary pump does not operate by depressing R.P. switch.	a. Fuse F2 blown b. Leak valve of rotary pump did not operate after shut down and pump oil flows back into foreline c. Relay Y1 or Y5 inoperative	a. Replace F2 b. Replace leak valve. If oil has flowed back, clean vacuum lines. c. Replace Y1 or Y5	F2 (15A) Leak Valve Y1 (MM2P) Y5 (MY4)
4	Evacuating sound of rotary pump does not cease.	a. Stage clamp knob set at CLAMP position on specimen chamber assembly b. Foreign matter (fibers etc.) adhering to o-ring between specimen chamber and door	a. Set stage clamp knob at UNCLAMP position b. Clean o-ring and o-ring surfaces.

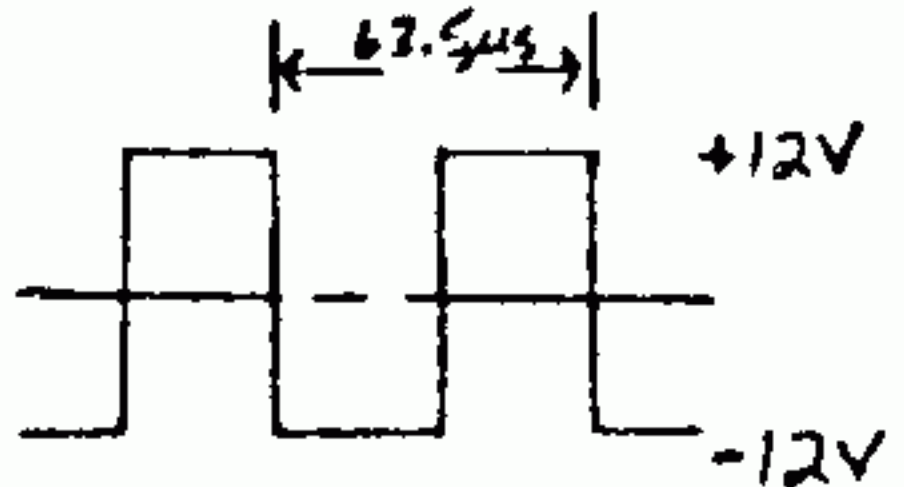
<u>TS No.</u>	<u>Symptom</u>	<u>Possible Cause</u>	<u>Remedy or Reference</u>	<u>Replacement Part</u>
	30kV - 60 μ A 15kV - 36 μ A 2kV - 4 μ A			
9	Loss of intensity on CRT °Check voltages on PC Board N82HD01P in high voltage power supply: CP4-GND: +15V CP5-GND: -15V CP3-GND: +75V °Check voltage in unit A of display console. On PC Board N82MA01P: CP2-GND: +15V CP3-GND: -15V	a. Fuse F1 blown in high voltage power supply Dwg. No. N83H03 b. No high voltage for CRT b-1 Voltage not supplied across CP2-GND on PC Board N82HD01P (Normally about +60V) b-2 No oscillator wave form across CP4-GND on PC Board N83HC01P Normal Wave Form:

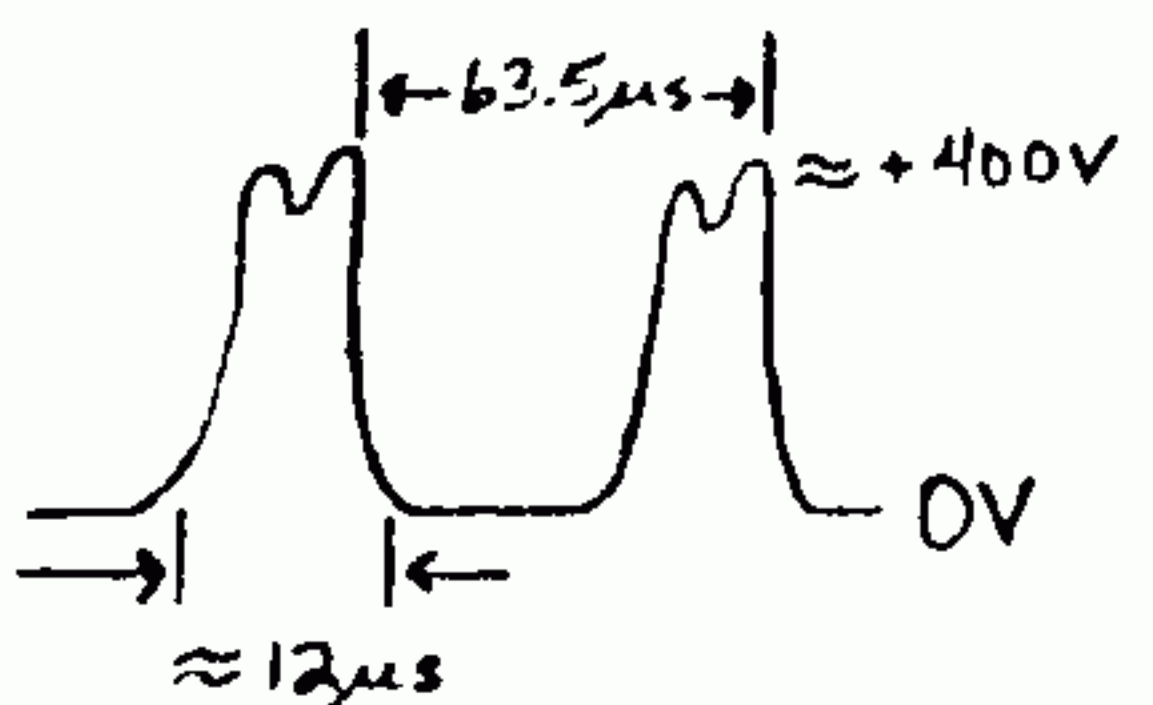
b-3 No wave form across CP1-GND on PC Board N80HB01P-B

a. Replace F1 b-1 Replace IC1 b-2 Replace IC4 b-3 Fuse F2-2 blown and TR7 defective in high voltage power supply drawing no. N83H03	F1 (5A) IC1 (741) IC4 (709) F2-2 (1A) TR7 (2SC643A) or (2SC1172)

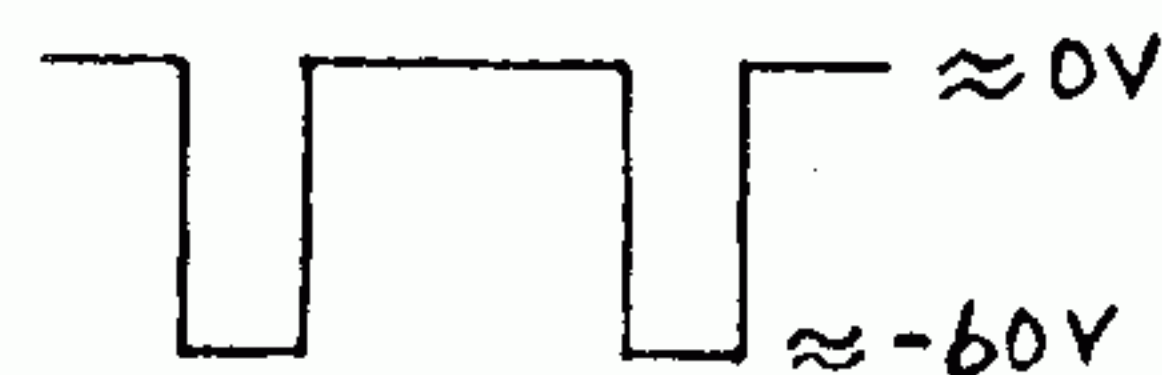
e. Scanning on CRT kept in blanking condition. About -60V is applied across CP5-GND on PC Board N82NK01P. Normal wave form:	e. Scanning on CRT kept in blanking condition. About -60V is applied across CP5-GND on PC Board N82NK01P. Normal wave form:	e. Replace IC7 on N82NC02P or IC5 TR4, TR5 on N82NK01P	IC7 (709) IC5 (709) TR4, TR5 (2SA510-0)

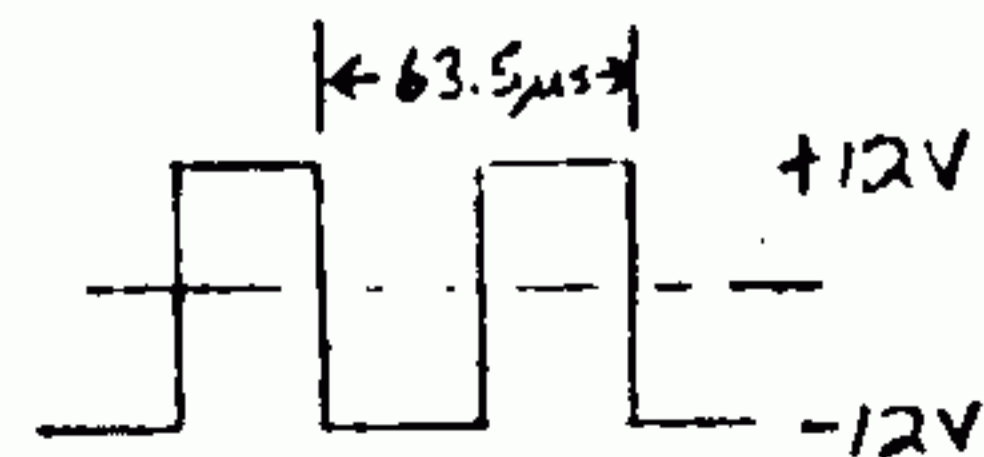
<u>TS No.</u>	<u>Symptom</u>	<u>Possible Cause</u>	<u>Remedy or Reference</u>	<u>Replacement Part</u>
		b-3 Disconnect preamplifier cable connector JN3 from rear of display console. Check as instructed in b-1 above. If the pointer does not deflect as described in b-1, IC8 defective.	b-3 Replace IC8 on PC Board N82NB02P	IC8 (709)
		b-4 If the pointer deflects normally, preamplifier or photomultiplier is defective.	b-4 Replace preamplifier. Replace photomultiplier.	Preamplifier Photomultiplier
12	Scan line can not be focused on CRT	a. CRT high voltage too low. Scan area too large in rapid scanning mode. Normal area: 60mm x 50 mm (approx.)		
		a-1 Voltage too low across CP2-GND on PC board N82HD01P. Normally: Approx. +60V	a-1 Replace IC1	IC1 (741)
		a-2 Frequency of wave form changing across CP4-GND on PC board N83HC01P. Normal frequency:	a-2 Replace IC4	IC4 (709)

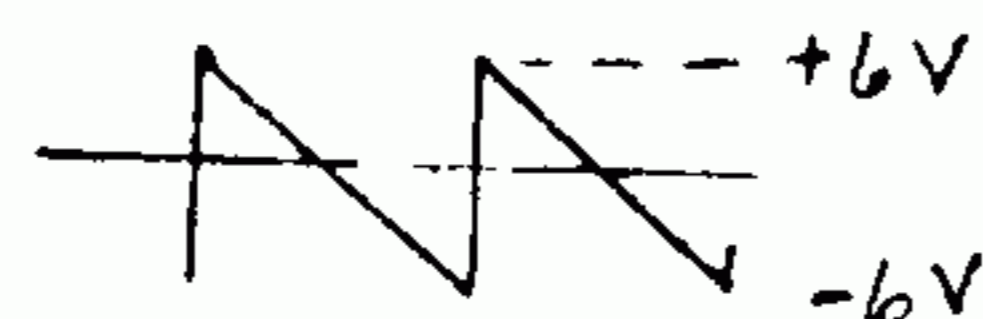
<u>TS No.</u>	<u>Symptom</u>	<u>Possible Cause</u>	<u>Remedy or Reference</u>	<u>Replacement Part</u>
		b. Voltage supplied to 4th grid of CRT too low (below +400V) Voltage too low across CP5-GND on PC Board N80HB01P-B in high voltage power supply. Normally approx. +400V (H.V. power supply check point #8)	b. Replace Zener diode ZD4, ZD5	ZD4, ZD5 (IN3710B)
13	CRT does not scan horizontally (in PHOTO, NORMAL, RAPID scanning mode) NOTE: In most cases, vertical scanning will occur at the left or right side of CRT just outside the frame. Increase brightness to observe. Check can also be made by selecting RAPID mode. ° Check voltage in unit A of display console.	a. Horizontal scan circuit not oscillating. No wave form across CP2-GND on PC board N82NB02P Normal Wave Form:	a. Replace IC3, although IC2 or IC5 may be defective on PC Board N82NB02P	IC3 (531) IC2, IC5 (709)

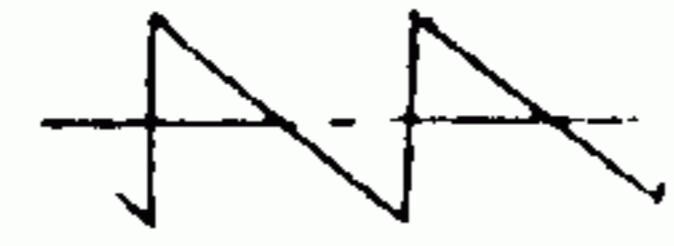
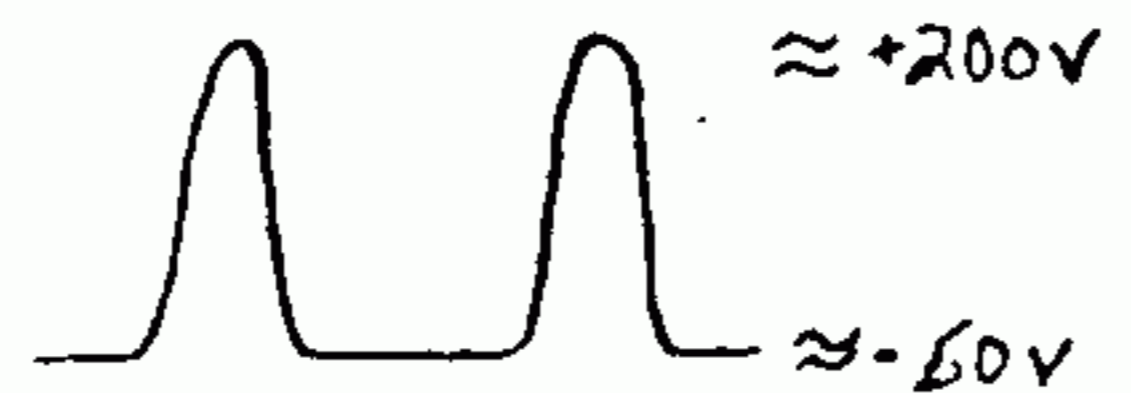
<u>TS No.</u>	<u>Symptom</u>	<u>Possible Cause</u>	<u>Remedy or Reference</u>	<u>Replacement Part</u>
	Voltage on PC board N82MA01P: CP2-GND: +15V CP3-GND: -15V	b. CRT scanning circuit defective. No wave form across CP3-GND on PC Board N80NA02P. Normal scanning wave form:	b. Replace IC5 on PC Board N80NA01P	IC5 (741)
	(In TV scanning mode)	c. CRT scanning circuit defective c-1 Voltage not supplied across CP3-GND on PC board N83NH01P. Normally approx. +6V +10V c-2 No wave form across CP2-GND on PC Board N83NH01P. Normal wave form:	c-1 Check and replace any one of TR2, TR3 on PC board N83NH01P and TR10 in display console. c-2 Replace TR9 in display console.	TR2,TR3 (2SC510-0) TR10 (2SD110-0) TR9 (2SC558)

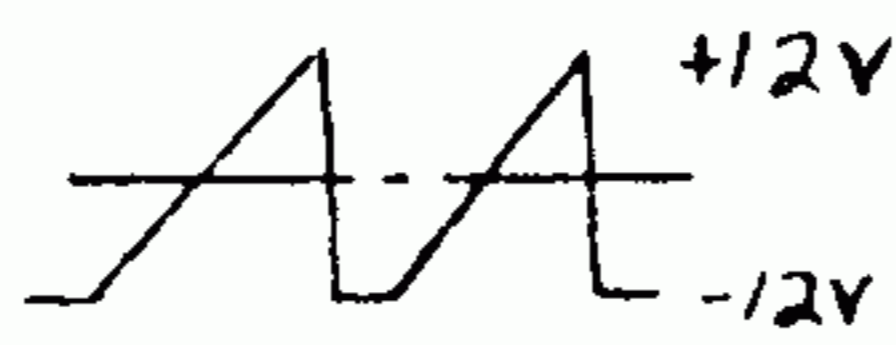
<u>TS No.</u>	<u>Symptom</u>	<u>Possible Cause</u>	<u>Remedy or Reference</u>	<u>Replacement Part</u>
14	<p>CRT does not scan vertically.</p> <p>NOTE: In most cases, horizontal scanning will occur at top or bottom of CRT just outside the frame. Increase brightness to observe. Check</p>	<p>a. Vertical scanning circuit does not oscillate. No wave form across CP1-GND on PC Board N82NC02P.</p> <p>Normal scanning wave form:</p>

<p>a. Replace IC3 although IC1 - IC5 may be defective on PC board N82NC02P.</p>	<p>IC3 (709) IC1 - IC5 (709)</p>
	<p>can also be made by selecting RAPID mode.</p>	<p>b. CRT scanning circuit defective. No wave form across CP4-GND on PC Board N80NA02P.</p> <p>Normal scanning wave form:</p>

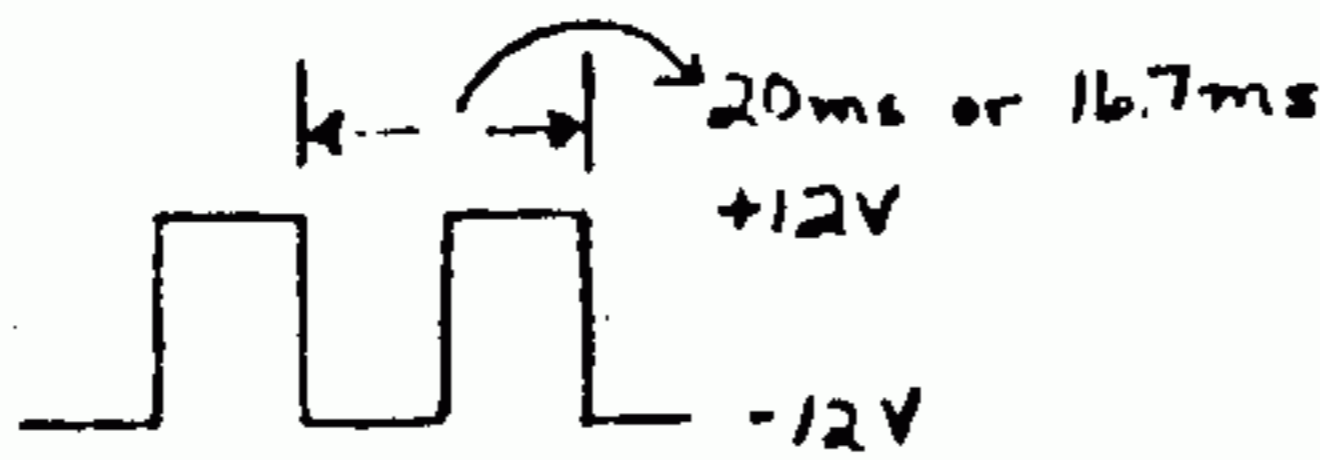
<p>b. Replace IC6 on PC Board N80NA02P</p>	<p>IC6 (741)</p>
15	<p>CRT scan lines not uniform. CRT horizontal scan not synchronized at line frequency in PHOTO, NORMAL and RAPID mode.</p>	<p>a. No line frequency across CP1-GND on PC Board N82NL01P</p> <p>Normal frequency:</p>

<p>a. Replace IC1 on PC board N82NL01P</p>	<p>IC1 (709)</p>

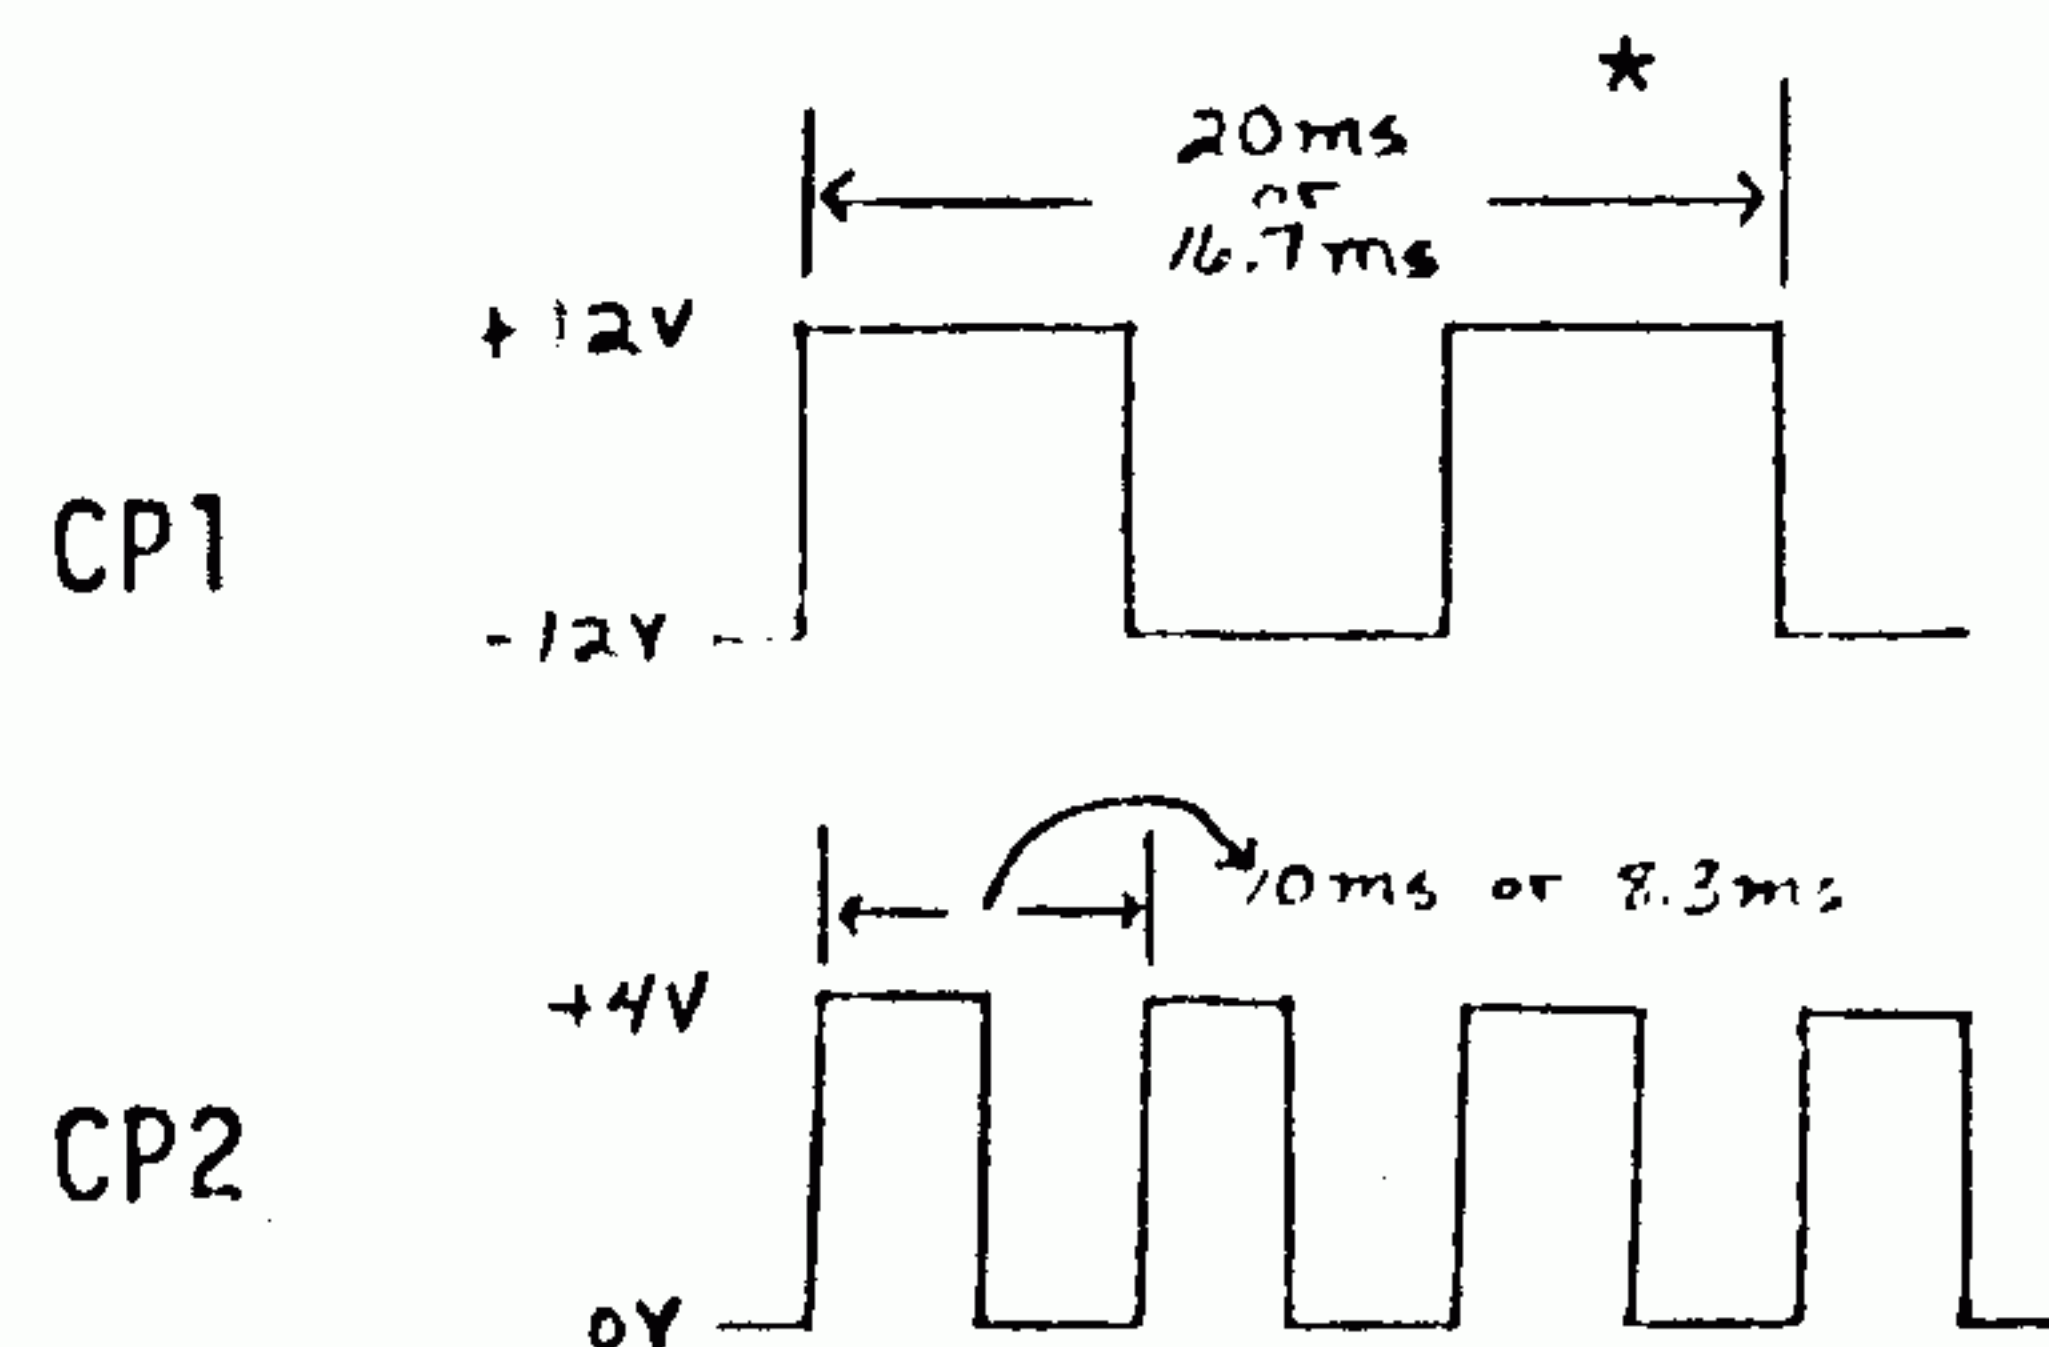
b. Abnormal wave form at CP2 on PC board N82NL01P.

Normal wave form:

*50-60 cycle operation.

b. Readjust RV1 (50K Ω). Replace IC2

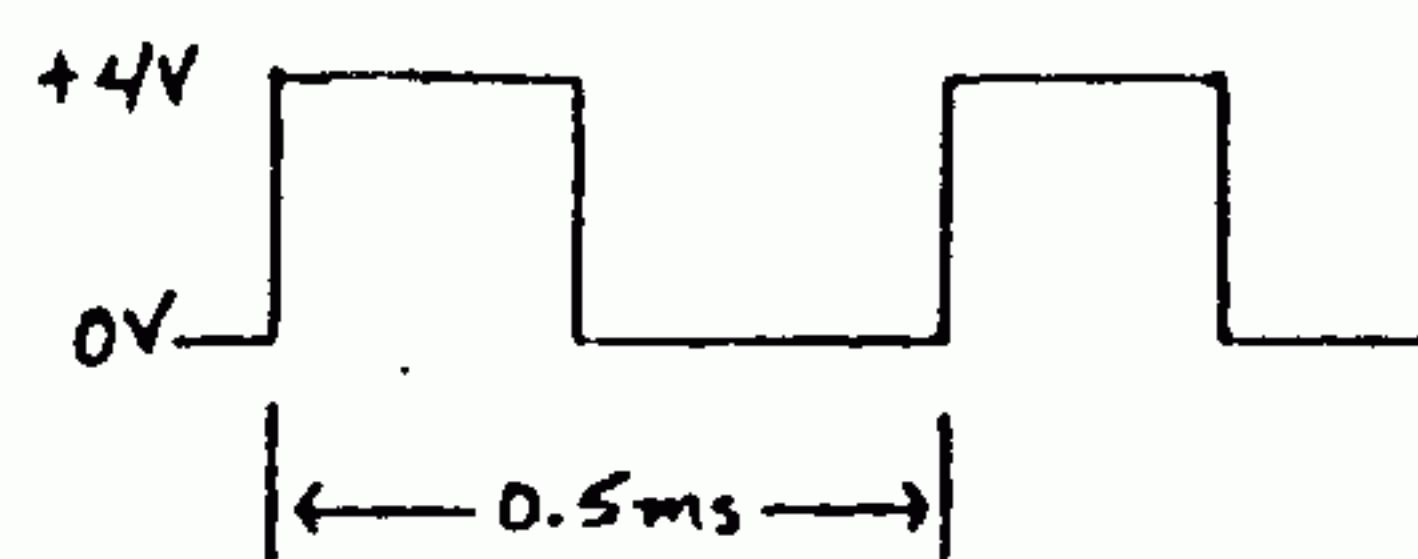
c. Abnormal wave form at CP3 on PC board N82NL01P.

Normal wave form:

c. Readjust RV2 (50k Ω)
Replace IC3

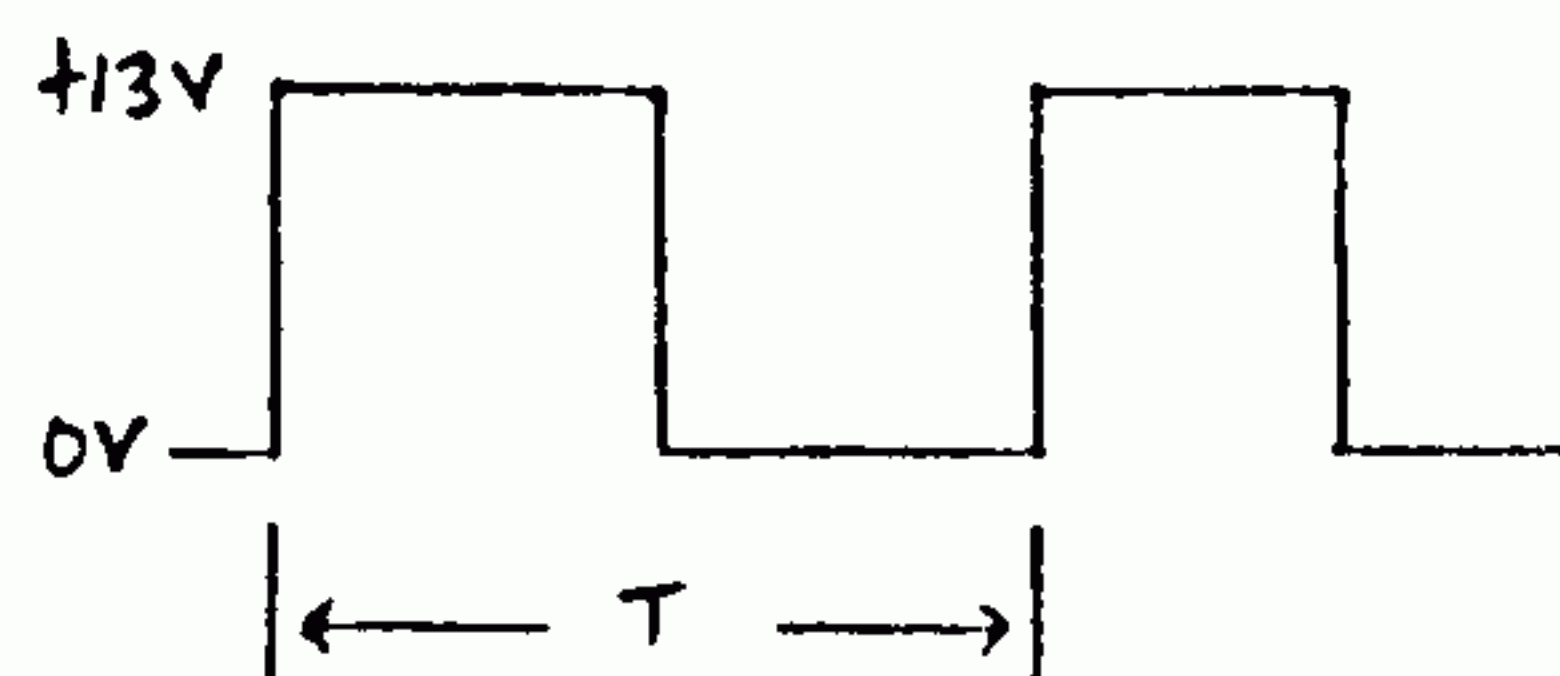
d. Abnormal wave-form at CP4 on PC board N82NL01P

Normal wave form:

T	
	DUAL OFF	DUAL ON
PHOTO	80ms or 66.8ms	40ms or 33.3ms
NORMAL	20ms or 16.7ms	10ms or 8.33ms
RAPID (full)	2ms	1ms
RAPID (red.)	1ms	1ms

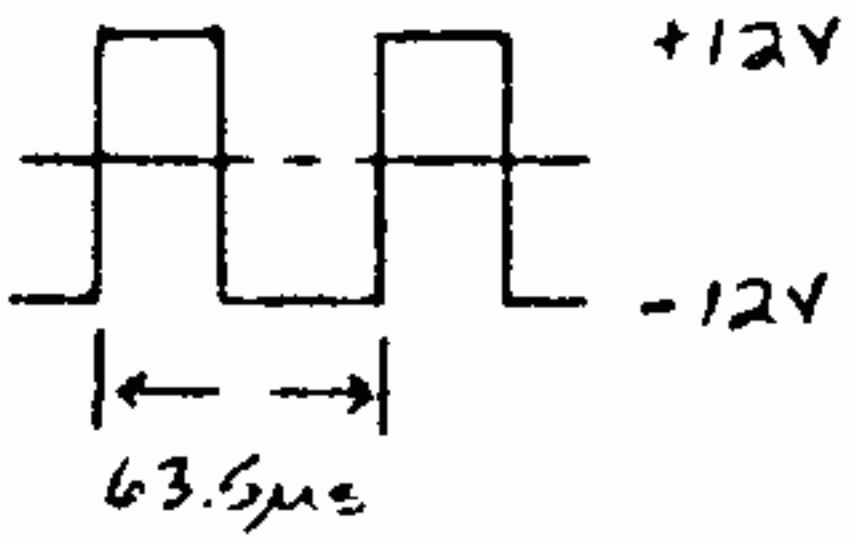
<u>TS No.</u>	<u>Symptom</u>	<u>Possible Cause</u>	<u>Remedy or Reference</u>	<u>Replacement Part</u>
18	When EMISSION control is turned fully CCW (No emission current), EMISSION meter pointer does not deflect or meter reading is far lower than the following value (normal electron gun H.V. is not supplied)	<p>a. No voltage across CP6-GND on PC board N83HC01P. Normally +60V ~ +65V (at electron gun high voltage of 25kV)</p> <p>b. No oscillator wave form across CP4-GND on PC board N83HC01P. Normal wave form:</p>

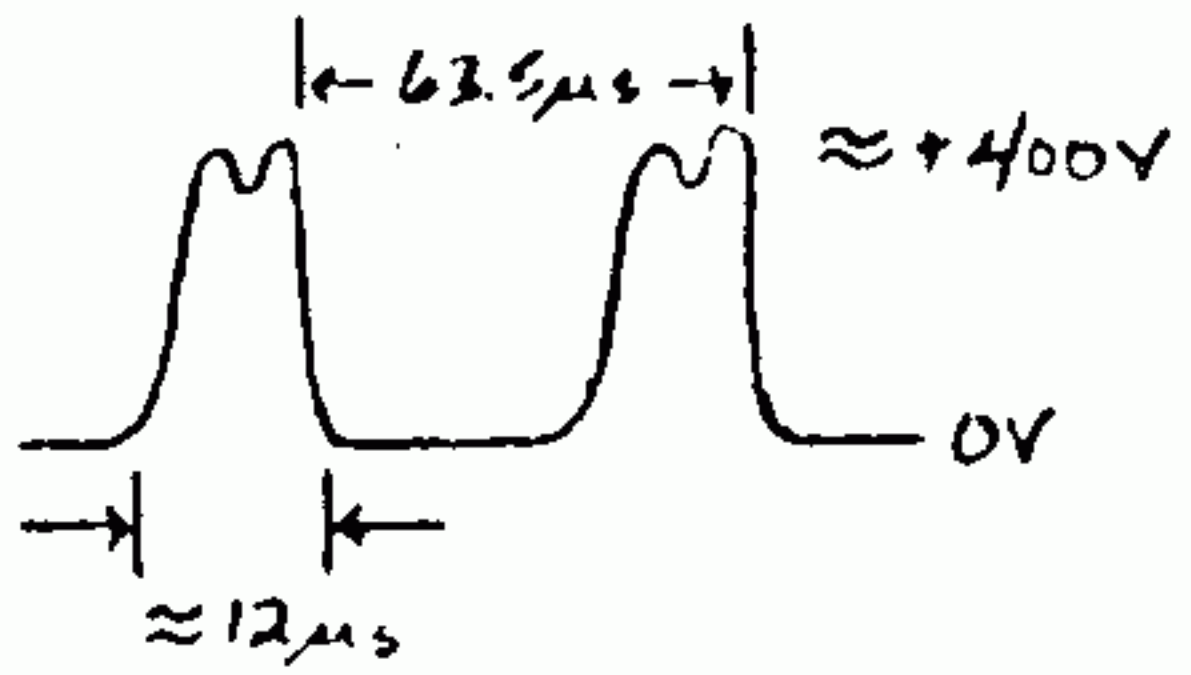
<p>c. Following wave form unavailable at check point #2 in H.V. power supply (N83H03) (at electron gun high voltage of 25kV):</p>

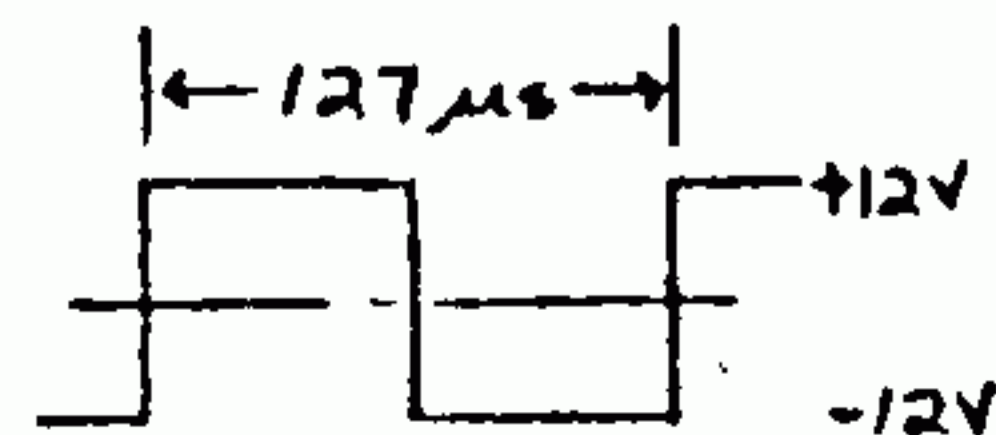
<u>S No.</u>	<u>Symptom</u>	<u>Possible Cause</u>	<u>Remedy or Reference</u>	<u>Replacement Part</u>
9	When EMISSION control is turned CW, EMISSION meter reading does not exceed value listed in TS No. 18 above.	<p>a. Filament open</p> <p>b. Poor contact between electron gun cartridge pin and socket in electron gun cable.</p> <p>c. Electron gun bias resistor open (electron gun cut off)</p> <p>d. Filament power supply defective</p> <p>d-1 Voltage not supplied across CP3-GND on PC board N83HC01P (when EMISSION control is turned clockwise). Normally, the voltage changes from 0V to about +30V by turning EMISSION control.</p> <p>d-2 No wave form across CP1-GND on PC board N83HC01P</p> <p>Normal wave form:</p>	<p>a. Replace electron gun cartridge (filament)</p> <p>b. Tighten sockets in electron gun cable.</p> <p>c. Replace one of R11 ~ R35 (100KΩ) in electron gun H.V. supply (N83HA08)</p> <p>d-1 IC2, TR2, TR3 and TR3 in H.V. power supply (N83H03) may be defective.</p> <p>d-2 Replace IC1 on PC board N83HC01P</p>	<p>Electron gun cartridge</p> <p>R11 ~ R35 (100KΩ)</p> <p>IC2 (741) TR2, TR3 (2SC484Y) TR3, (2SD110)</p> <p>IC1 (709)</p>

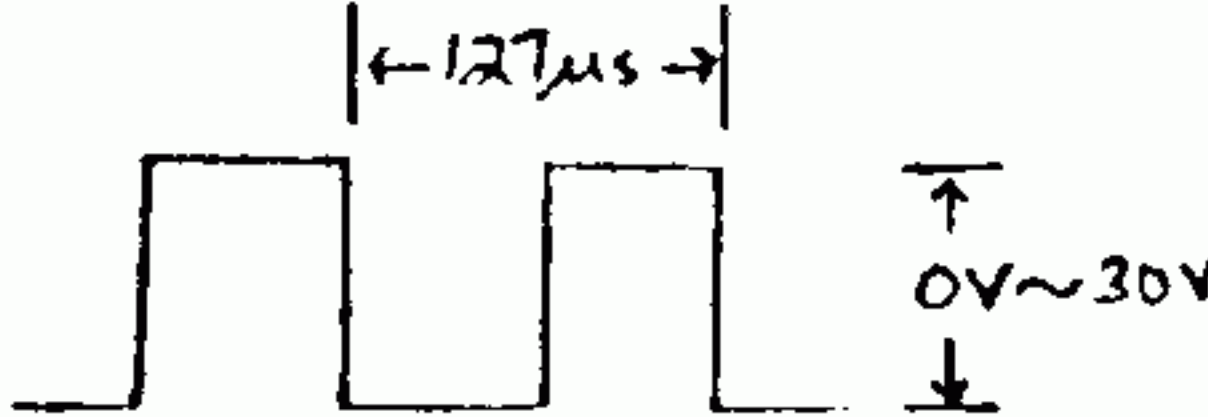
<u>TS No.</u>	<u>Symptom</u>	<u>Possible Cause</u>	<u>Remedy or Reference</u>	<u>Replacement Part</u>
		d-3 No wave form on collector of power transistors TR1, TR2 (2SC643A) in H.V. power supply (N83H03). When EMISSION control is turned clockwise, wave form should normally be as follows:	d-3 Replace TR1, TR2 in H.V. Power Supply (N83H03).	TR1, TR2 (2SC643A)

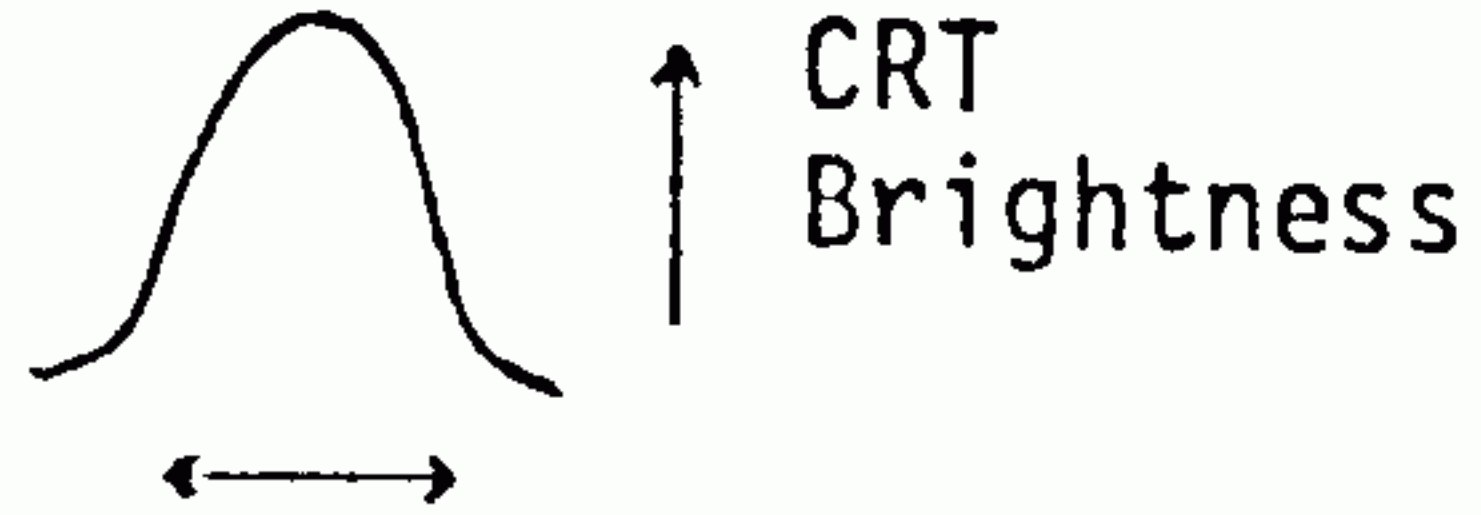
e. Image amplifier defective. See 9-f	e. See 9-f	See 9-f
22	Signal on CRT can not be maximized by beam alignment.	a. Filament not saturated. b. Filament tip miscentered in cap of electron gun cartridge	a. See Section 6 of instruction manual b. Recenter filament

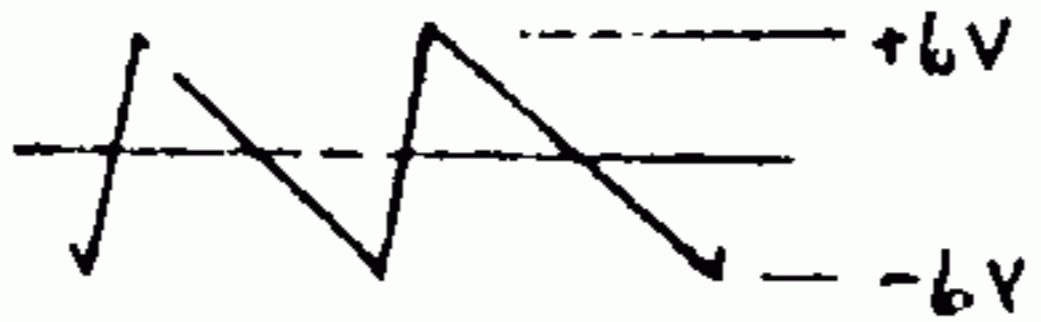
<u>TS No.</u>	<u>Symptom</u>	<u>Possible Cause</u>	<u>Remedy or Reference</u>	<u>Replacement Part</u>
33	Image elongated horizontally (in PHOTO, RAPID or NORMAL scanning mode)	<p>a. Horizontal scan inoperative.</p> <p>a-1 Horizontal scan defective. No wave form across CP2-GND on PC board N82MB02P Normal Wave Form:</p>

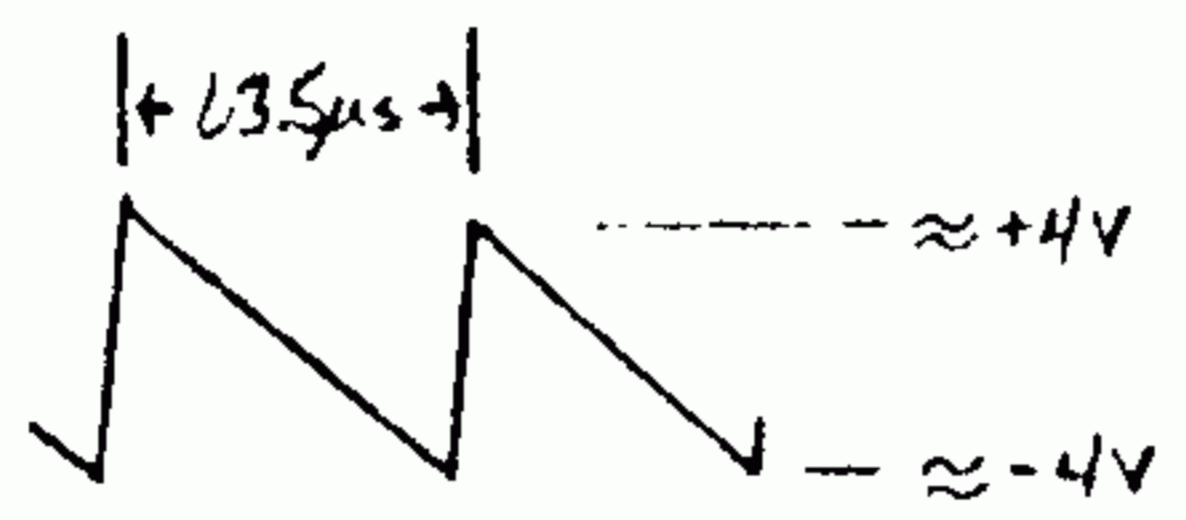
<u>TS No.</u>	<u>Symptom</u>	<u>Possible Cause</u>	<u>Remedy or Reference</u>	<u>Replacement Part</u>
		a-2 Wave form distorted across CP2-GND on PC board N83ND02P Normal wave form:

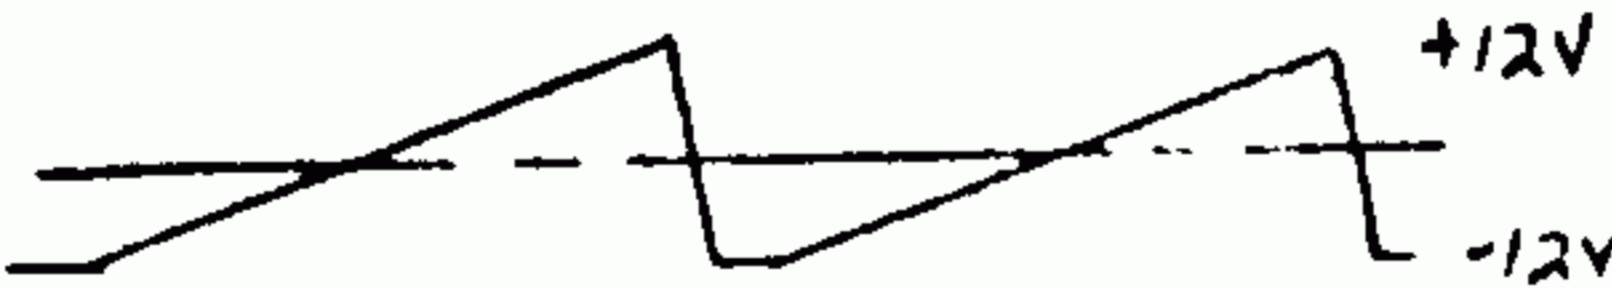
a-2 IC1, TR4 through TR8 or TR11, TR12, TR13, TR14 in display unit B may be defective.	IC (531) TR4, TR7, TR8 (2SC51) TR5, TR6 (2SA510) TR11, TR12 (2SA663) TR13, TR14 (2SC558)
		a-3 Resistor in magnification selector switch open in display unit B. (N82N11)	a-3 See TS No. 33-a-3	
35	Image elongated vertically.	a. Vertical probe scan in-operative. a-1 Vertical scan circuit defective. Wave form distorted across CP1-GND on PC board N82NC02P. Normal wave form:

a-1 IC1 through IC5 may be defective	IC (741) IC (709)
		a-2 Wave form distorted across CP2-GND on PC board N80NA02P.	a-2 IC4, TR9 ~ TR16 or TR3, TR4 in display unit B may be defective.	IC (741) TR9, TR11 (2SC372) TR10, TR12 (2SA495) TR13, TR16 (2SC484)

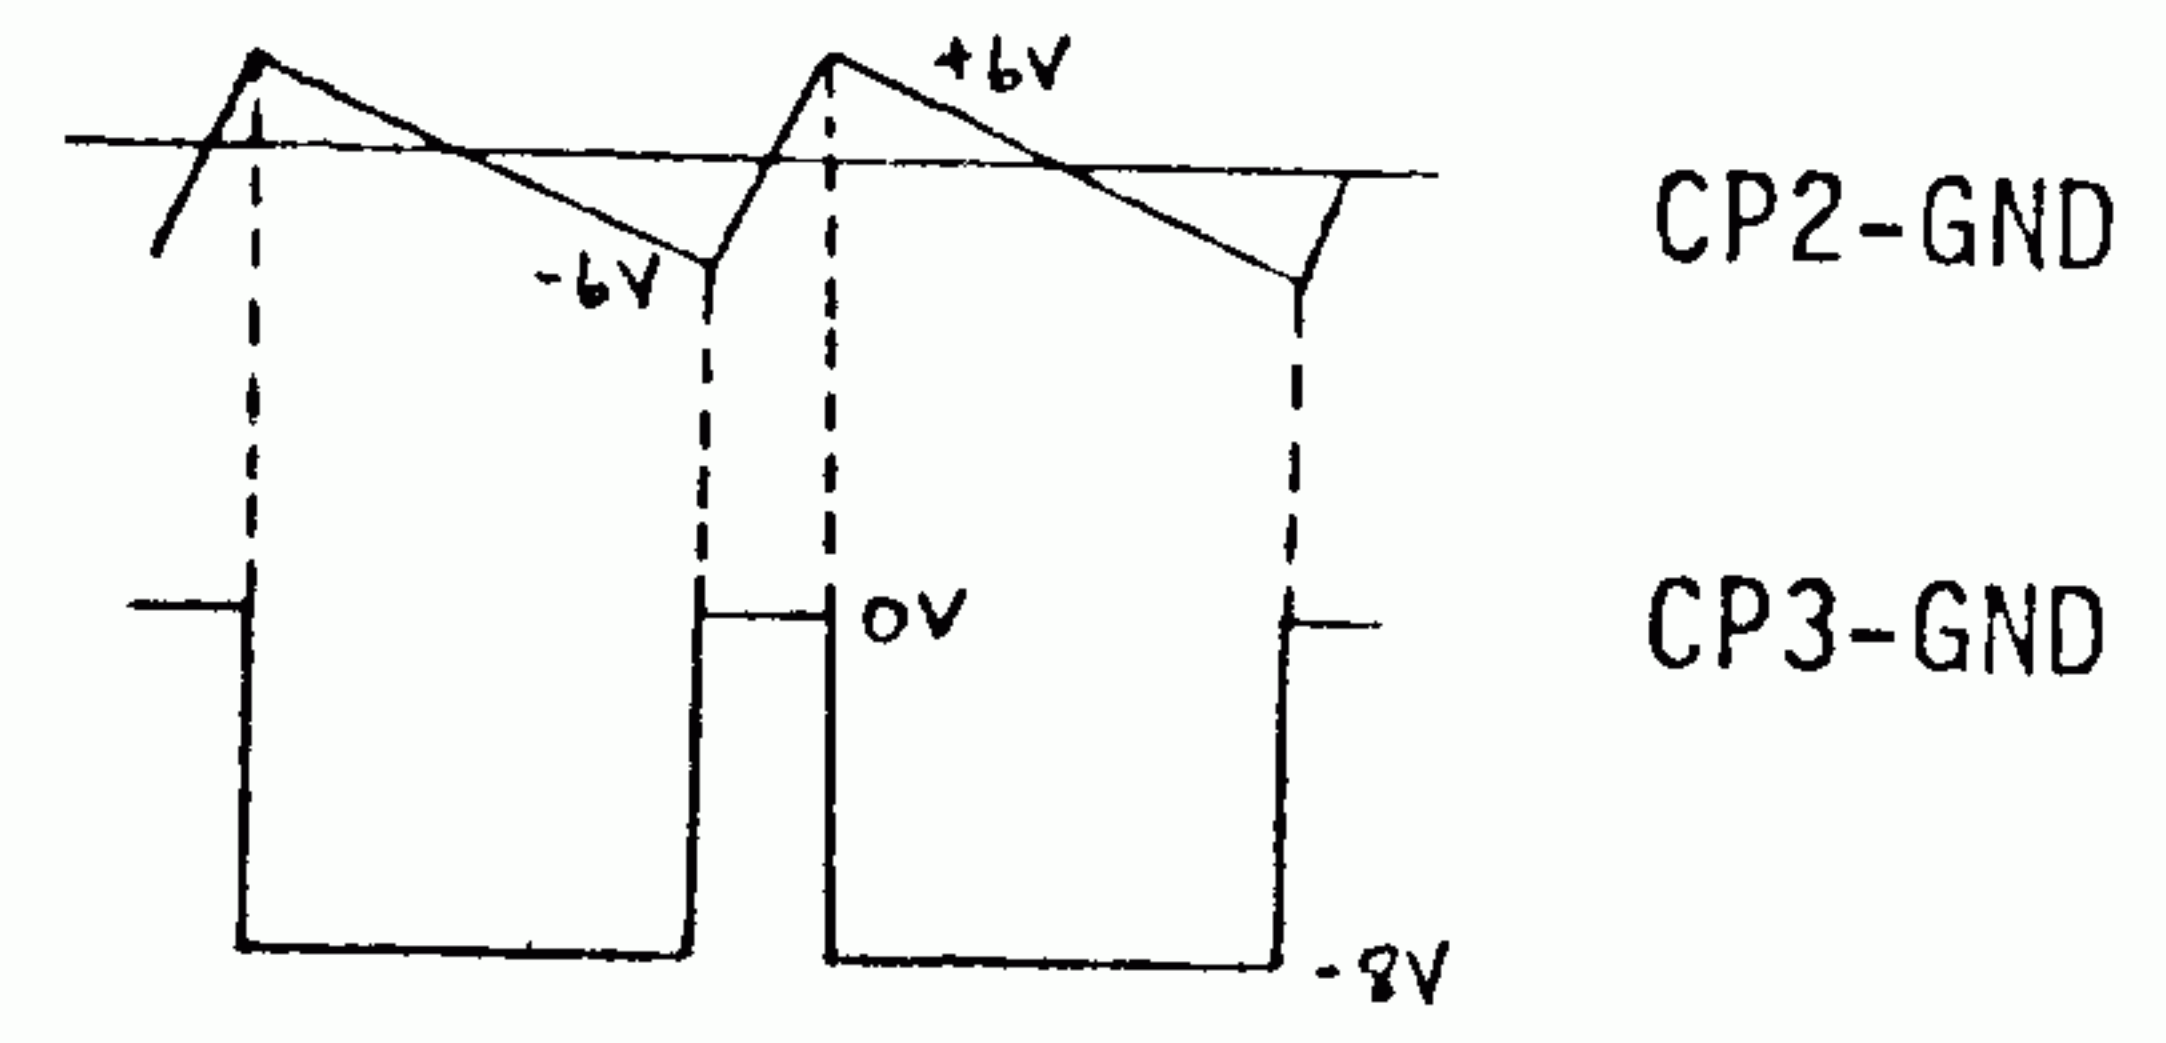
37	Image shadowed on left side (doubled image) especially on the right side of CRT.	a. No horizontal blanking. a-1 In PHOTO or NORMAL scan mode; Improper correlation between wave form across CP2-GND and wave form across CP3-GND on PC board N82NB02P. Normal correlation (in phase)	a-1 Replace IC6 on PC board N82NB02P	IC (709)
----	--	---	--------------------------------------	----------

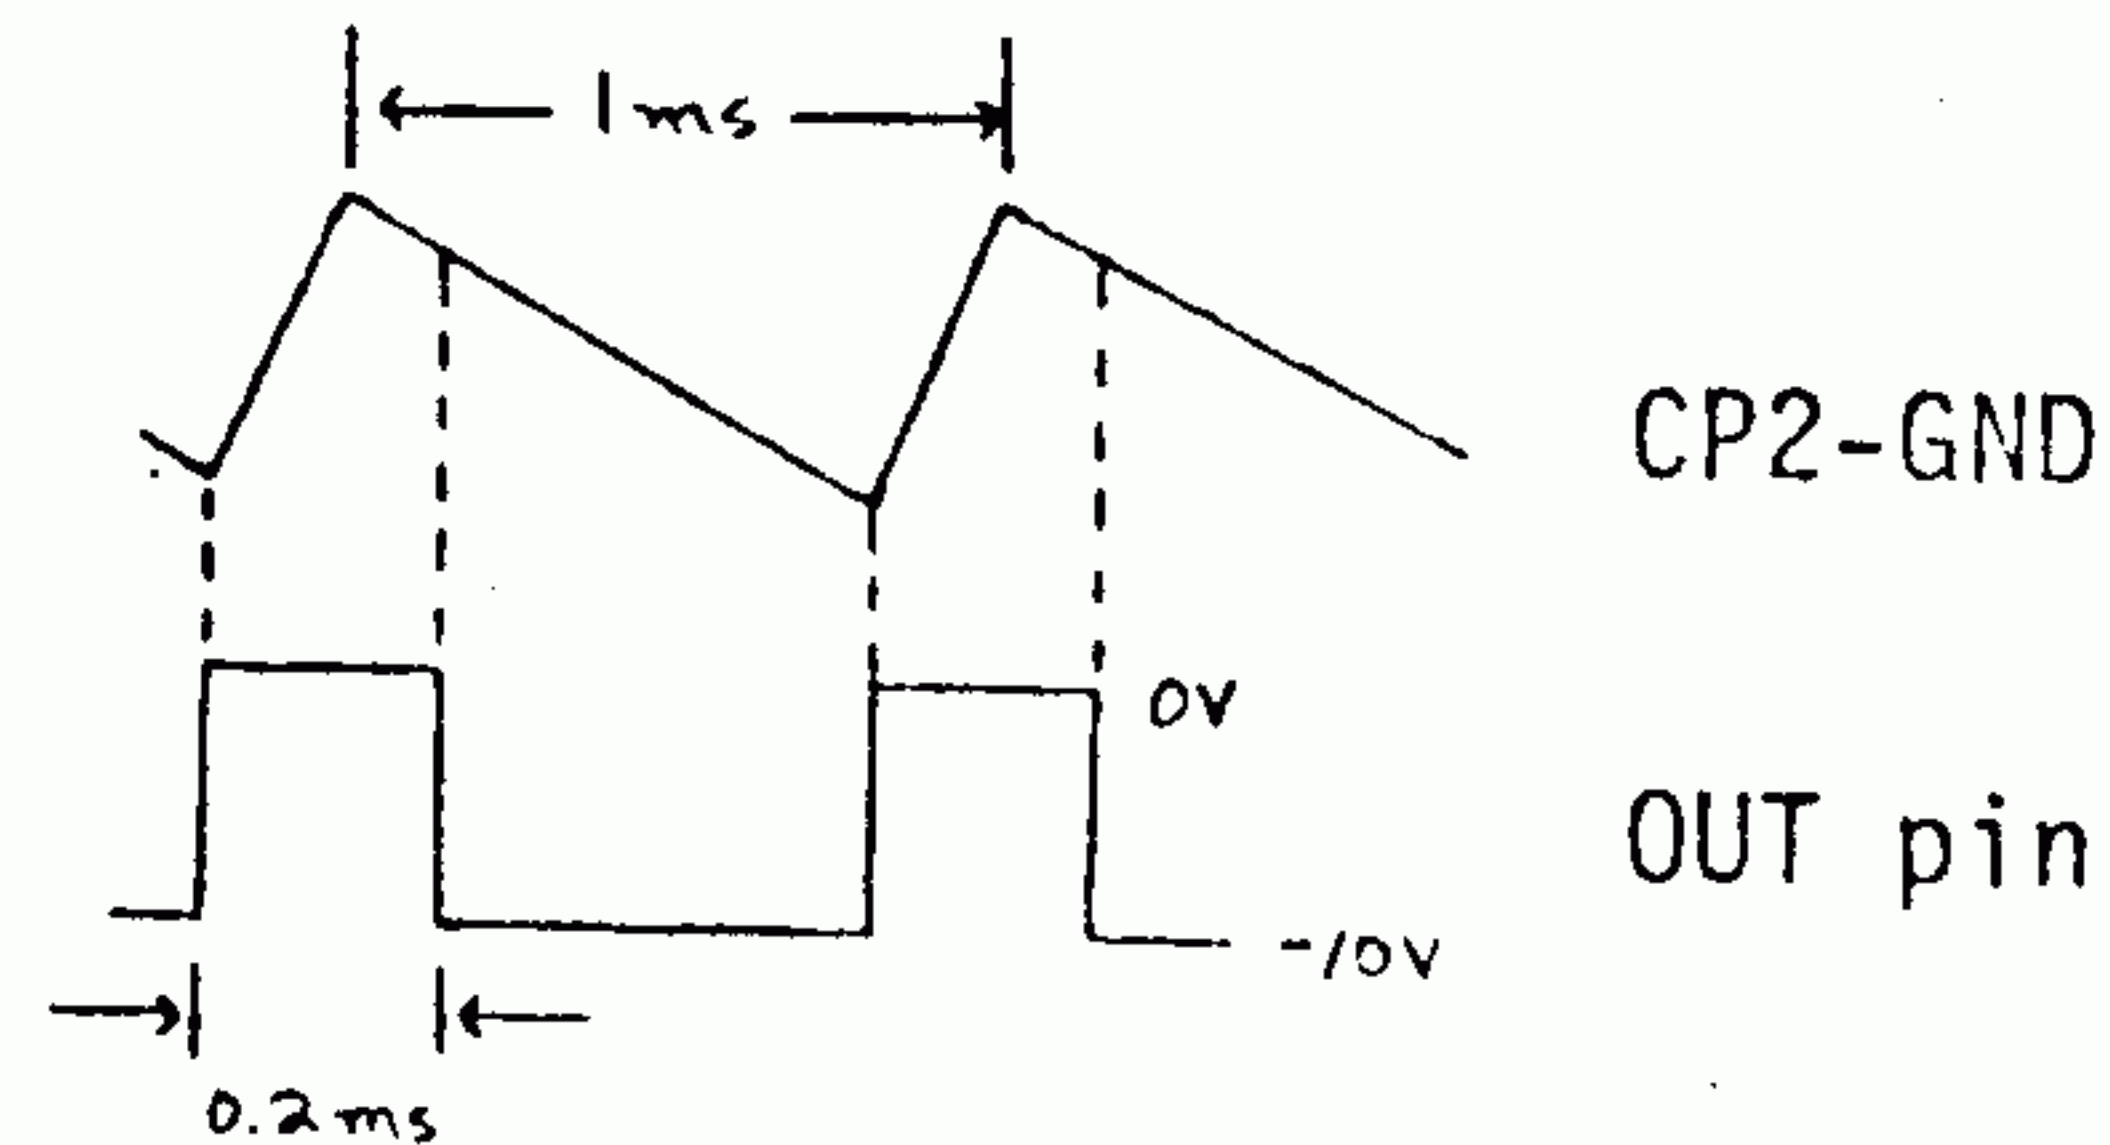
a-3 In RAPID scan mode: Phase incorrect between wave form across CP2-GND on PC board N82NB02P and wave form at OUT pin on PC board N82NJ01P
Normal in Phase:

a-3 Replace IC1 on PC board N82NJ01P. Adjust blanking width by adjusting RV1 (100 k Ω)

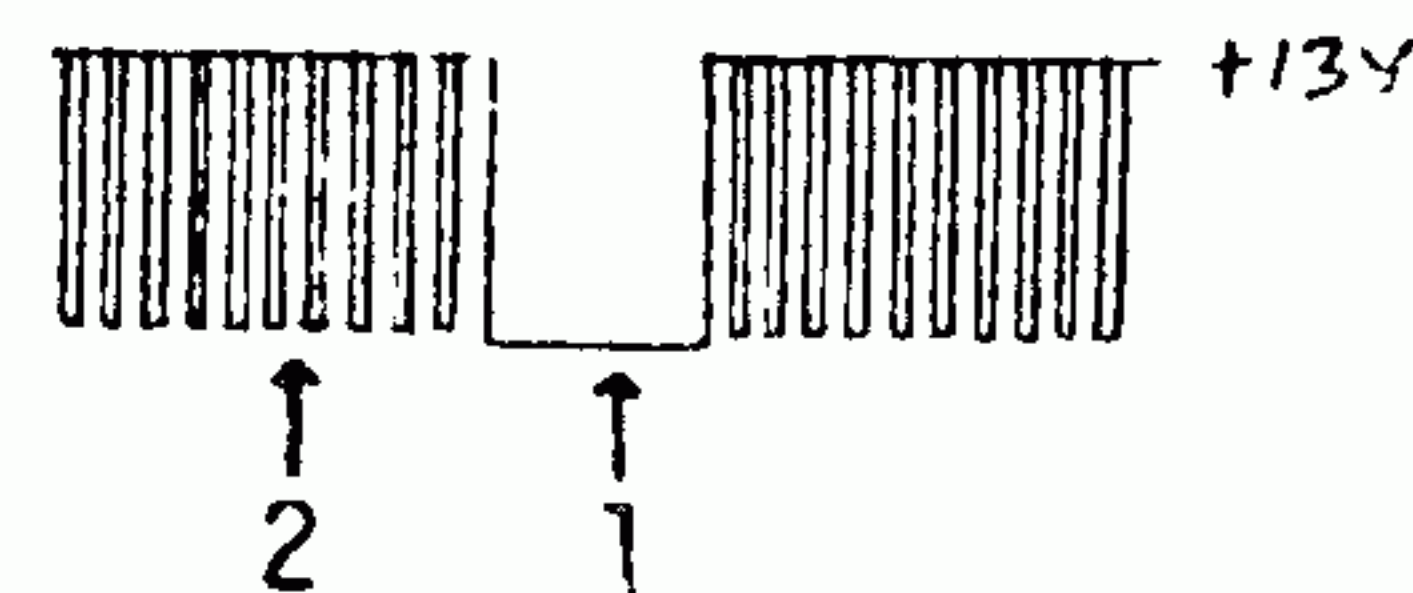
a. Wave form for vertical scan incorrect across CP3-GND on PC board N82NC02P.
Normal wave form:

1. Blanking for vertical scan
2. Blanking for horizontal scan

a. IC7 defective on PC board N82NC01P

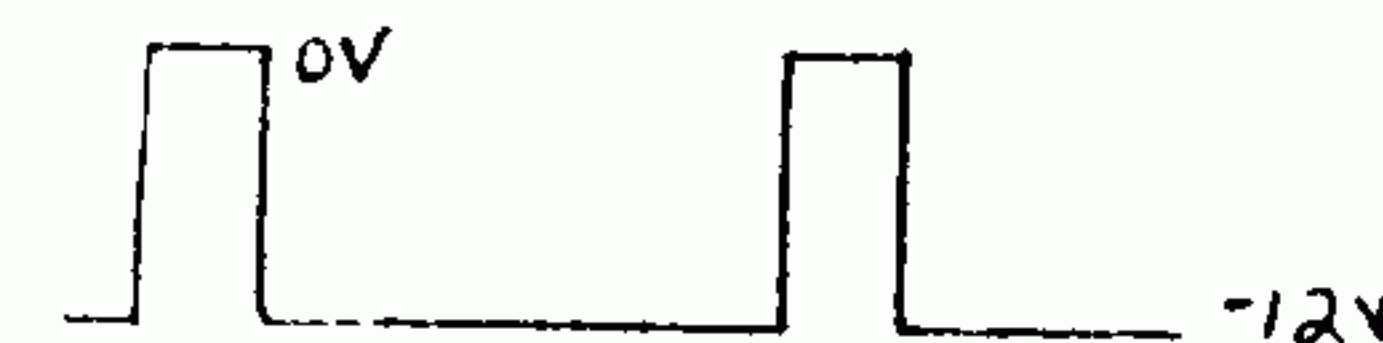
When only blanking wave form for vertical scan is not available, the following blanking wave form is not available from collector of TR2 (2SA495G-0) on PC board N82NC02P:

TR2, TR1 may be defective

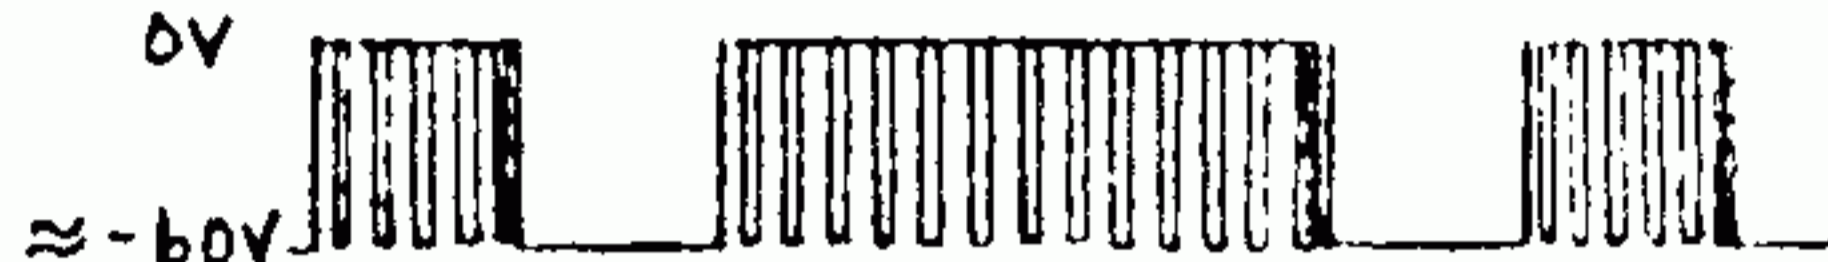
<u>TS No.</u>	<u>Symptom</u>	<u>Possible Cause</u>	<u>Remedy or Reference</u>	<u>Replacement Part</u>
38		b. Improper blanking at CP5-GND on PC Board N82NK01P. Normal wave form at CP5.

b. Replace IC9, IC10, IC5, and/or TR4, TR5.	IC9 (7404) IC10 (7400) IC5 (709) TR4, TR5 (2SA510)
39	Specimen image smearing or jumps at some specific area (bright horizontal strips may be visible)	a. Charging up on specimen surface	a. Coat specimen surface with carbon, gold, etc. See section 4 of instruction manual.	
40	Ragged edge on image due to vibration.	a. Specimen stub not fixed securely to specimen holder. b. Shaft set screw for specimen holder loose.	a. See section 4 of instruction manual b. See section 4 of instruction manual	
41	Backlash in stage X and Y controls.	a. Screw loose on X control shaft b. Screw loose for Y control shaft.	a. Tighten screw. b. Tighten screw.
