<u>TS No.</u>	<u>Symptom</u>	<u>Possible Cause</u>	<u>Remedy or Reference</u>	<u>Replacement Part</u>
1	Cooling water does not flow to diffusion pump.	a. Water pressure too low b. Cooling water lines for diffusion pump clogged.	a. Increase flow rate b. Unclog or replace water lines	
2	Instrument is not energized by depressing POWER switch.	a. Loss of power to instrument b. Fuse F1 blown c. Relay Y4 inoperative	a. Check circuit breaker for line supplying power to instrument. b. Replace F1 c. Replace Y4	F1 (15A) Y4 (MY4)
3	Rotary pump does not operate by depressing R.P. switch.	a. Fuse F2 blown b. Leak valve of rotary pump did not operate after shut down and pump oil flows back into foreline c. Relay Y1 or Y5 inoperative	a. Replace F2 b. Replace leak valve. If oil has flowed back, clean vacuum lines. c. Replace Y1 or Y5	F2 (15A) Leak Valve Y1 (MM2P) Y5 (MY4)
4	Evacuating sound of rotary pump does not cease.	a. Stage clamp knob set at CLAMP position on specimen chamber assembly b. Foreign matter (fibers etc.) adhering to o-ring between specimen chamber and door	a. Set stage clamp knob at UNCLAMP position b. Clean o-ring and o-ring surfaces.

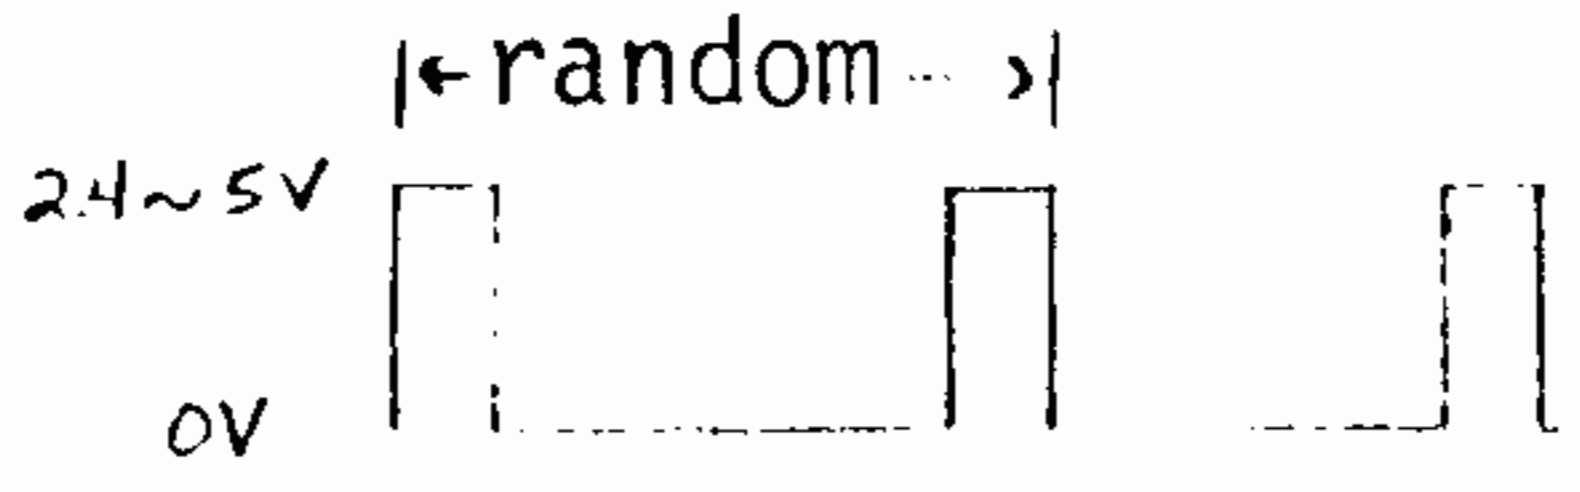
45	When IMAGE MODE selector switch is set at X-ray pos. 1. No X-ray image.	1.A Defective TR1, TR2, TR3, IC8, IC9, IC10 on N82NK01P. No signal at CP4. Normal waveform:	1.A Replace IC8, IC9, IC10, TR1, TR2, TR3	TR1, TR2, TR3 (2SC372) IC8 (7400) IC9 (7404) IC10 (7400)

<p>The diagram shows a square wave pulse. The vertical axis is labeled '24~5V' and the horizontal axis is labeled '←random→'. The pulse is a single rectangular wave with a sharp rise and fall.</p>

1.B If A is normal, IC11, TR6 may be defective.	1.B Replace IC11, TR6	IC11 (7420) TR6 (2SC372)
	2. X-ray image reversed.	2.A Polarity selector switch S1 on N82NK01P improperly set	2.A Set selector switch to opposite position.	
46	When IMAGE MODE selector switch is set at SPOT, LINE position.

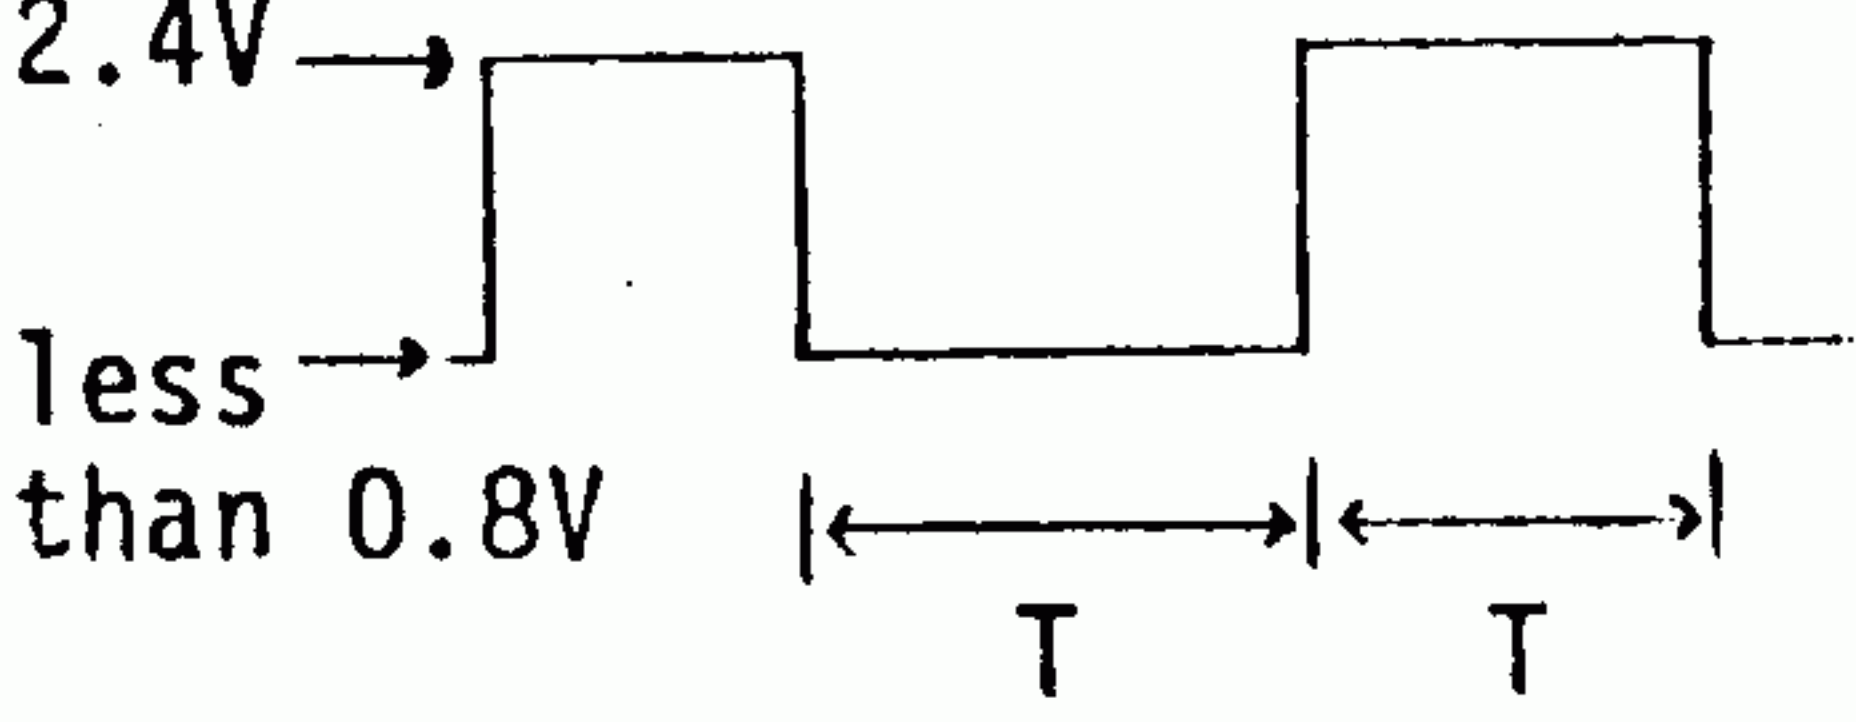
52	No intensity on CRT or vertical scan only with dual mag ON (x1, x3, x5 x10)	a. Switching circuit of Dual Mag. defective. Normal wave form not available at CP5 on N82NL01P. Normal wave form: more than 2.4V → less than 0.8V →

T: Horizontal Sweep time T (Dual Mag ON) PHOTO 40ms or 33.3ms NORMAL 10ms or 8.33ms RAPID (full) 1ms RAPID (reduced) 1ms	a. Replace IC19, IC14, IC15, and/or IC13 on N82NL01P	IC13 (7404) IC14 (7400) IC15 (7473) IC19 (7420)
		b. When item a is normal IC17 does not switch on N82NK01P-2/2	b. Replace IC4, IC5 on N82NL01P IC17, IC13 and IC15 on N82NK01P	IC4, IC5 (709) IC17 (CD4066) IC13 (741) IC15 (741)

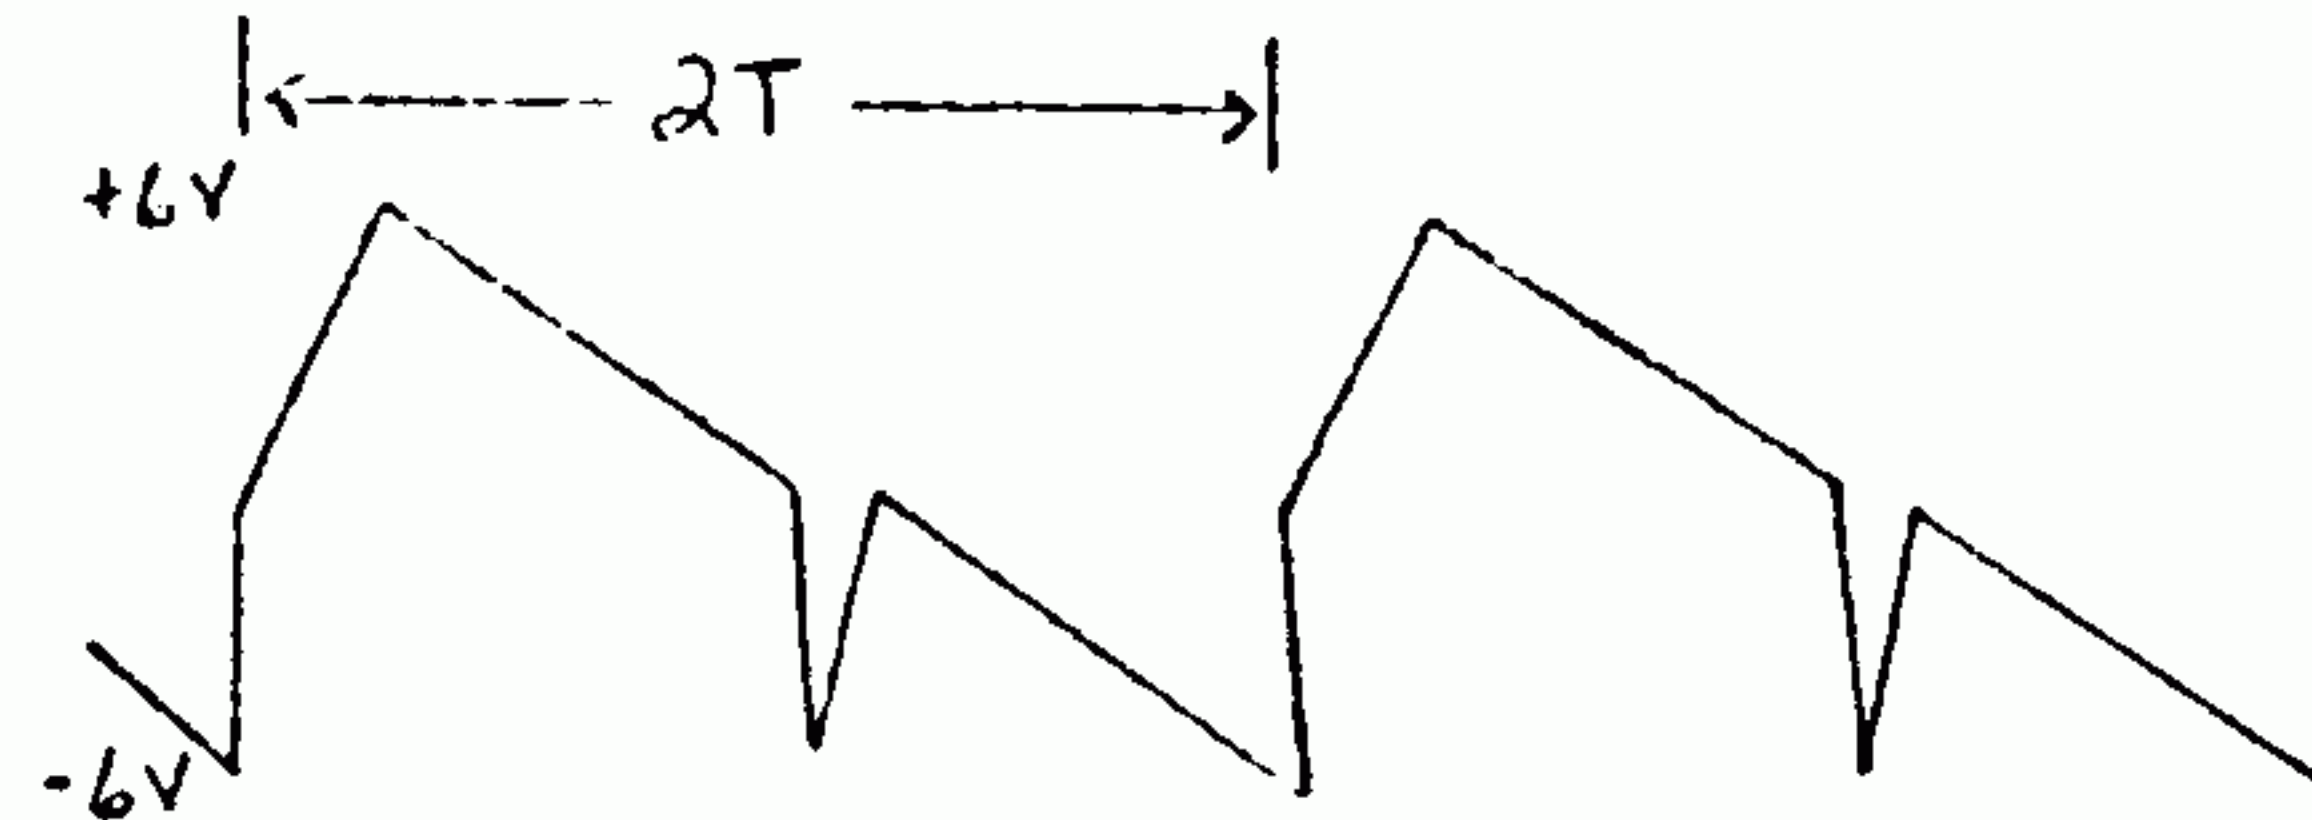
Normal wave form: (CP8)

T: Horizontal sweep time.

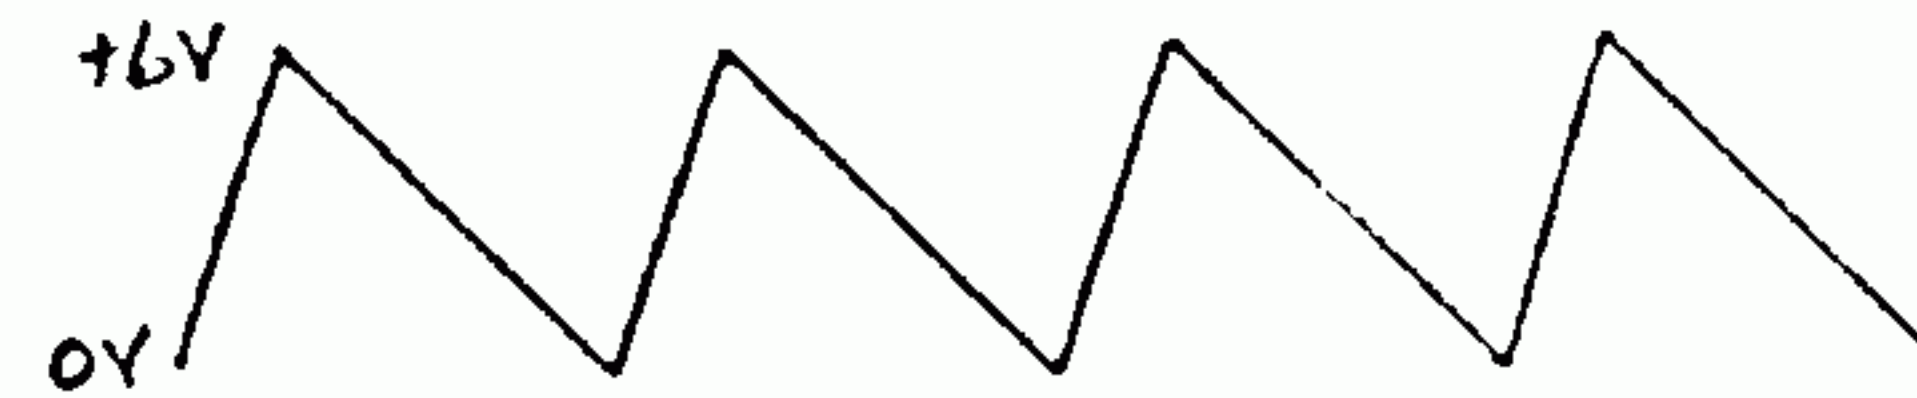
(Reference: Normal wave form at CP2 on N82NB02P Dual Mag. ON)

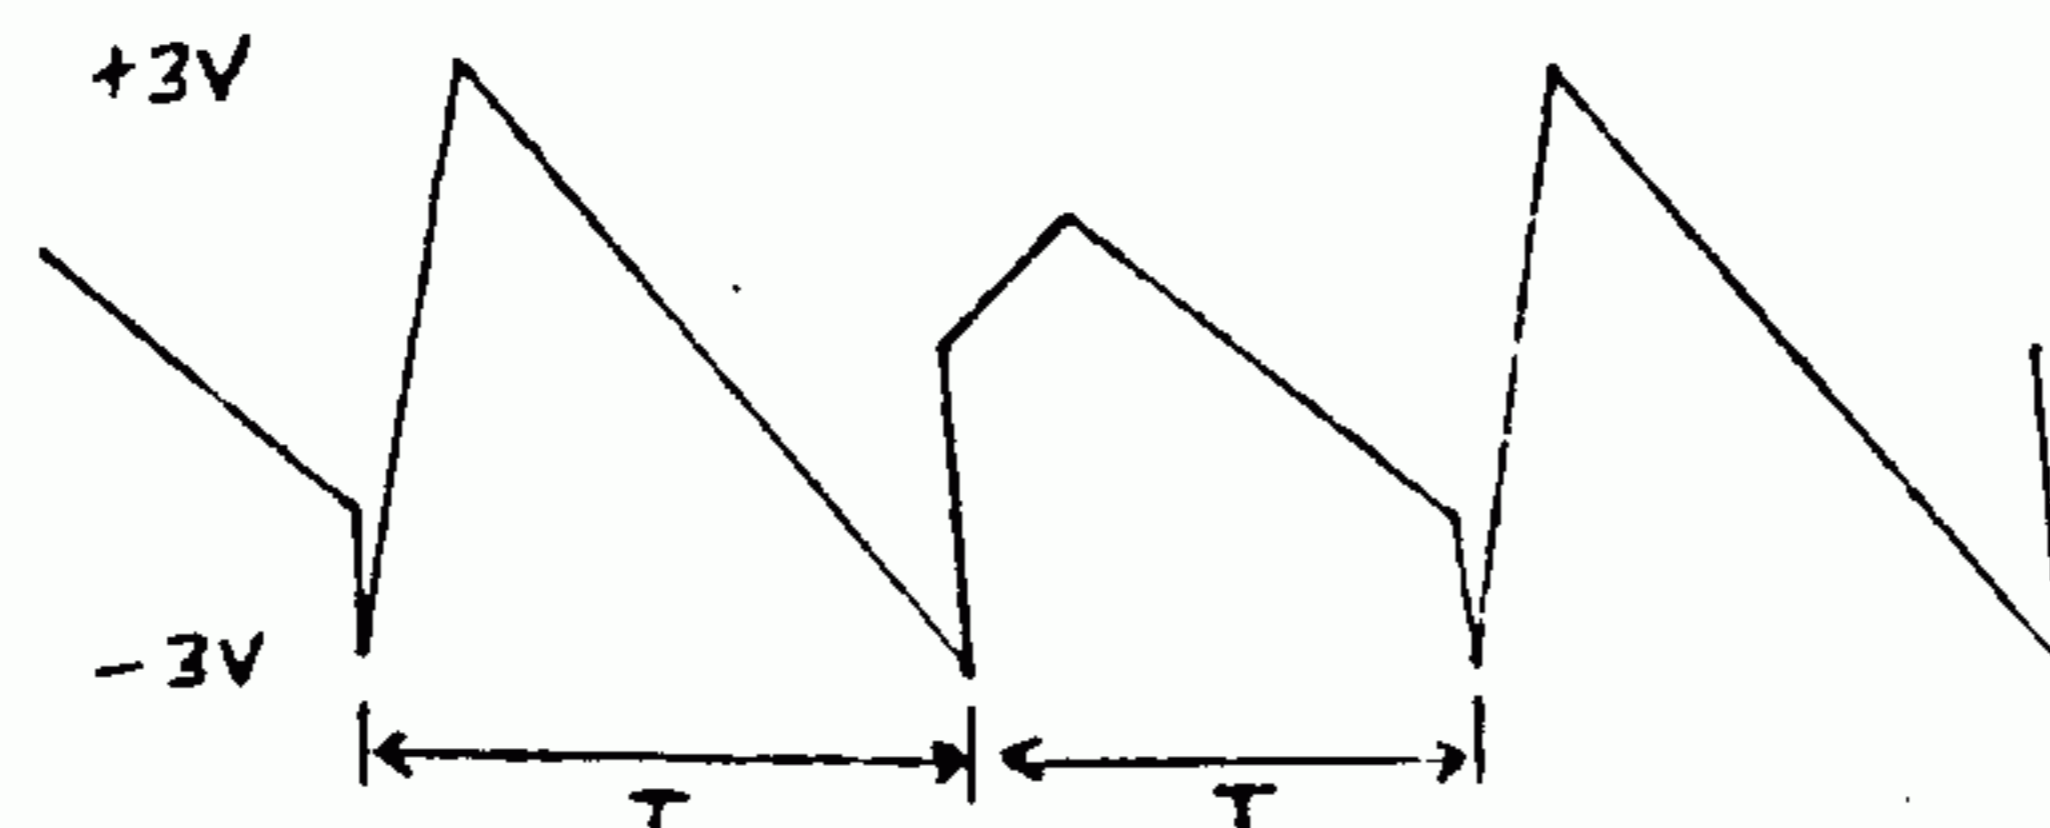
<u>TS NO.</u>	<u>Symptom</u>	<u>Possible Cause</u>	<u>Remedy or Reference</u>	<u>Replacement Part</u>
54	Dual ON or OFF image mode selector switch does not operate properly. (TS No. 24 and 38 is normal)	a. Image switching circuit does not operate, defective IC1 ~ 4, IC7 and IC8 on N82NK01P-1/2	a. Replace IC1 IC2, IC3, IC4 and/or IC7, IC8	IC1 (CD4066) IC2, IC3, IC4 (709) IC7, IC8 (7400)
55	a) Both low mag. and high mag images are horizon. elongated b) Either low mag. or high mag. image is horizontally elongated.	a) No horizontal probe sweep.	a)-1 Replace IC12, and/or IC14 on N82NK01P-2/2 a)-2 Replace relay Y14 in N82N11.	IC12 (741) IC14 (741) Y14 (MH6PG 12V AC)
		b) No horizontal probe sweep on one side only (Reference: Normal wave form at CP7 on N82NK01P-2/2 Dual x2. Dual position knobs at center.	b) Replace IC17 and/or IC16	IC17 (CD4066) IC16 (741)

T: Horizontal sweep time

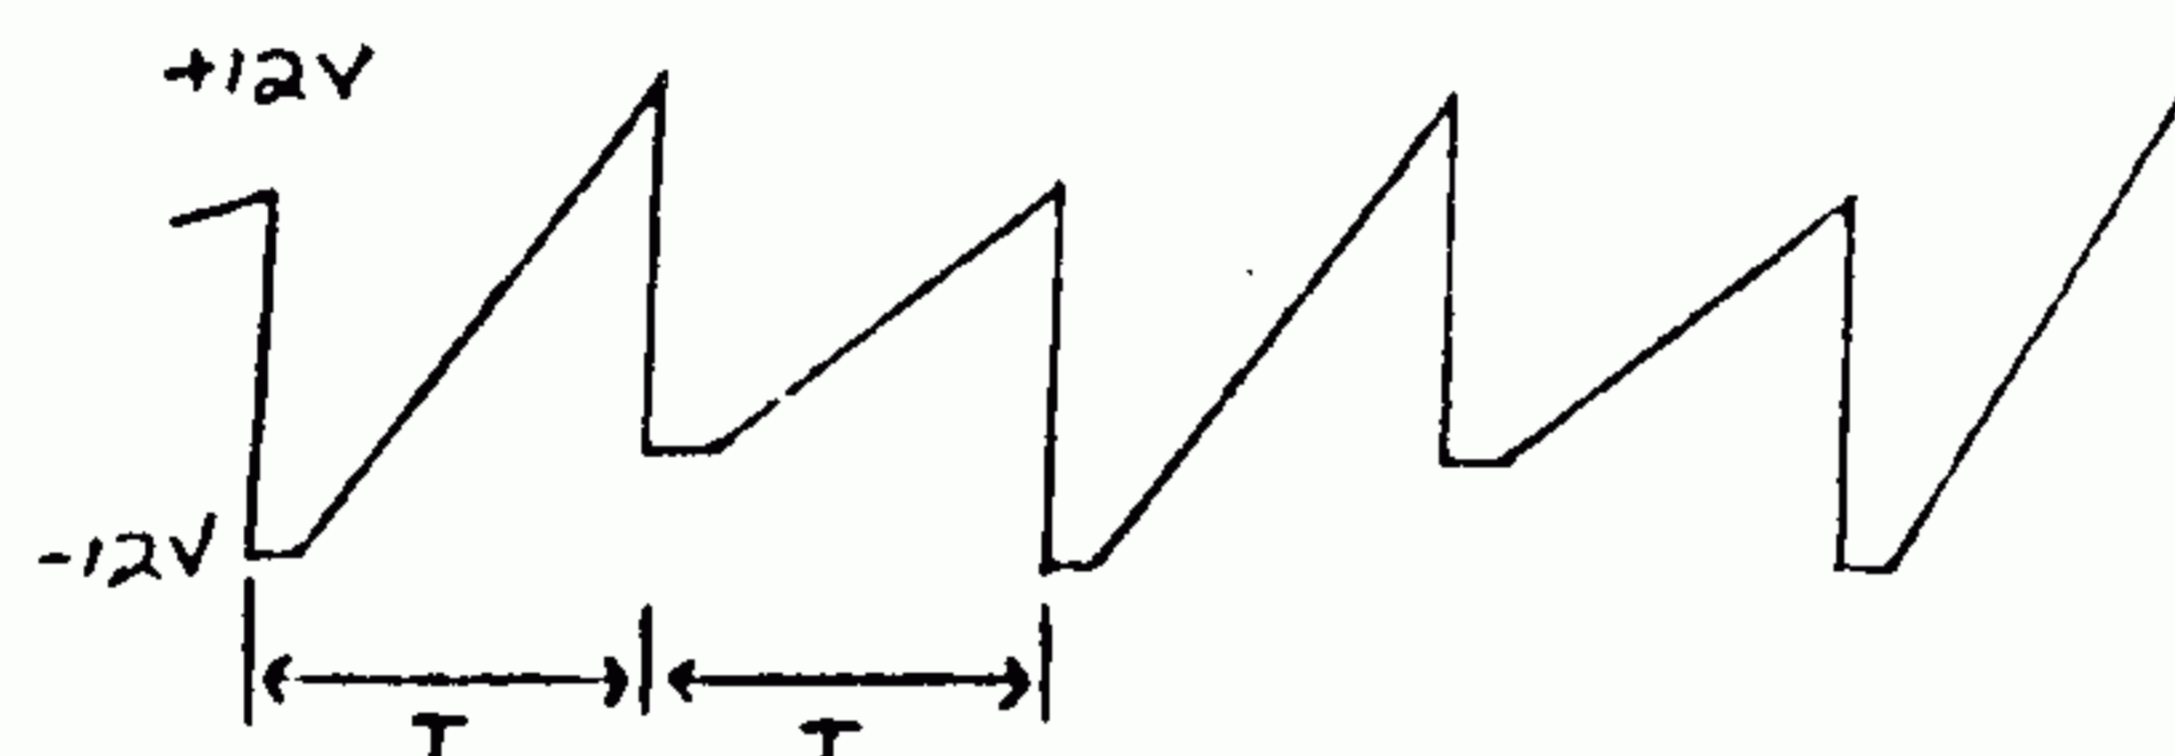
<u>TS No.</u>	<u>Symptom</u>	<u>Possible Cause</u>	<u>Remedy or Reference</u>	<u>Replacement Part</u>
56	a) Both low mag. and high mag. images are vertically elongated.	a) No vertical probe sweep	a)-1 Replace IC1, IC3 on N82NM01P a)-2 Replace relay Y14 in N82N11	IC1, IC3 (741) Y14 (MH6PG 12V DC)
	b) Either low mag. or high mag. image is vertically elongated.	b) No vertical probe sweep on one side only. (Reference: Normal wave form at CP1 on N82NM01P) (Dual x2, dual position knobs at center)	b) Replace IC14 IC2 on N82NM01P	IC14 (CD4066) IC2 (741)

T: Vertical sweep time.

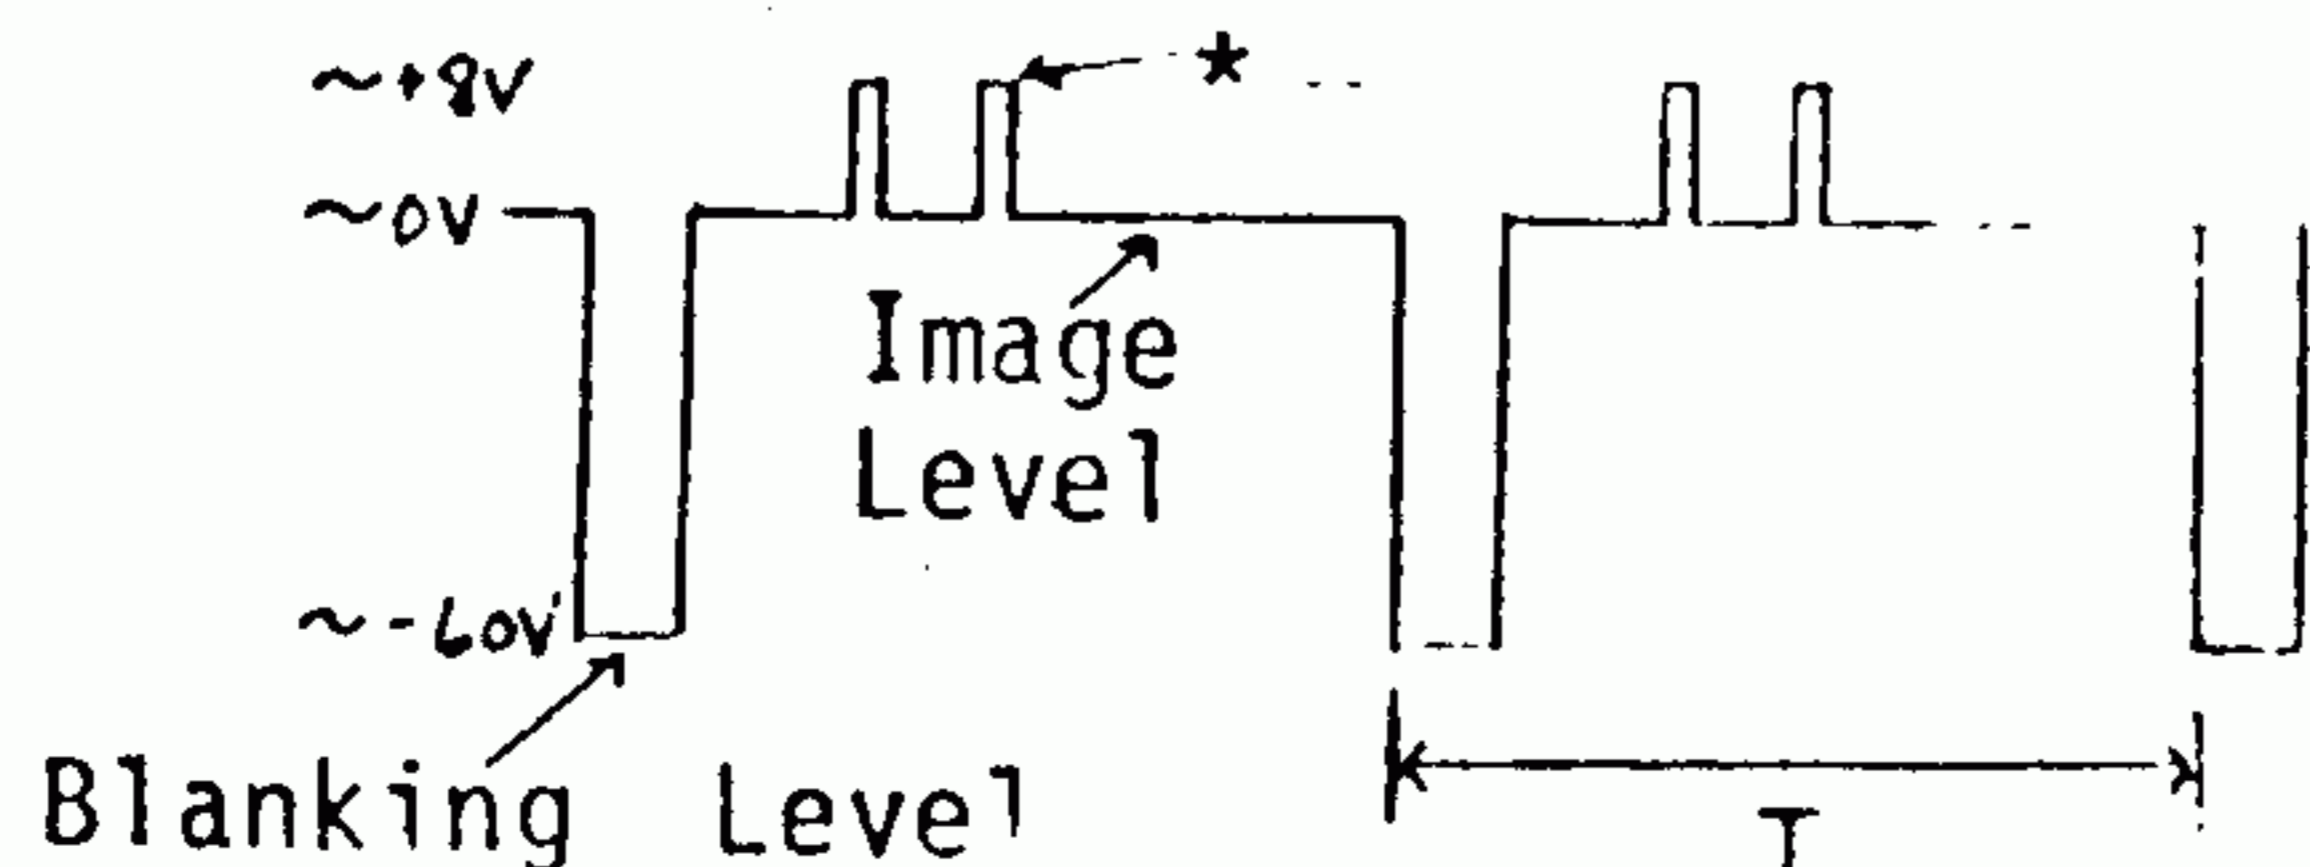
57	Dual window marker and μ marker do not appear on CRT. (regardless of whether dual mag. is on or off)	a. Defective IC11, IC9 and/or IC10 on N82NK01P-1/2 Normal wave form not available at connector pin No. 21 of N82NK01P-1/2. Normal wave form at connector pin No. 21.	a. When connector pin No. 8 of N82NK01P- 1/2 is grounded, check if image becomes brighter. a-1 If image becomes brighter, refer to TS No. 58 and 59. a-2 If image does not become brighter, replace IC11, IC9 and/or IC10 on N82NK01P-1/2	IC11 (7420) IC9 (7404) IC10 (7400) IC11 (7420) IC9 (7404) IC10 (7400)
----	--	---	---	--

T: Horizontal sweep time
